July 25, 2016

Bal-Last block fit adjustment.

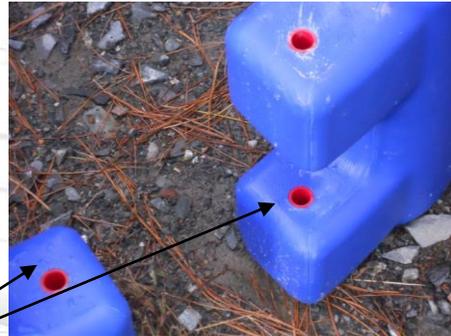
Because the mold shell material is thicker, the pin sleeves are fitting tighter on some of the blocks and slightly expanding the block at this location. The result can be a slightly tighter assembly of the ballast block system.
