## **Town of Falmouth - Partnership with Coastal Systems Program**

### **Mill Pond Nutrient Removal Pilots Update**

**Water Quality Management Committee Town of Falmouth**

**August 17, 2021**

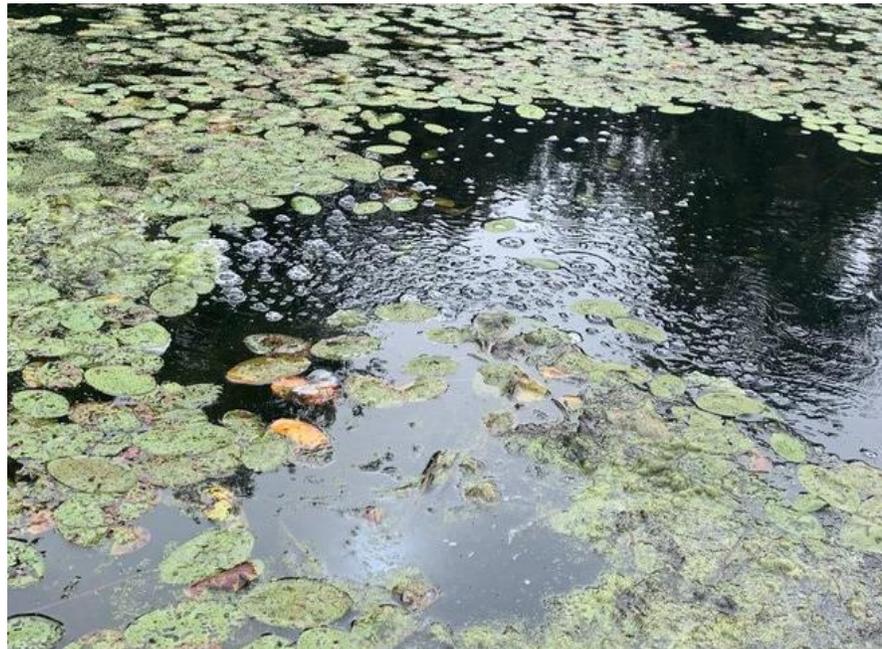
Figure III-1. Surface bubbles from bottom deployed nano-bubble aeration system in operation in the SE part of Mill Pond, Falmouth.

The Mill Pond aeration system put in place in mid-August 2020 was producing nano-bubbles with very little surface expression (Figure III-1). Its implication in Mill Pond was to release nano-bubbles that would oxygenate the sediments so that the phosphorus would remain trapped with the iron-oxides<sup>2</sup>, which in turn would improve water quality and habitat by limiting nutrient recycling of P that adds to P inputs from runoff and senescing plant matter. Phosphorus release has been found to be significantly controlled by limiting the level of oxygen depletion in bottom waters. This requires that the input of oxygen through aeration is sufficient to make up for the oxygen taken up in-pond waters and sediments.

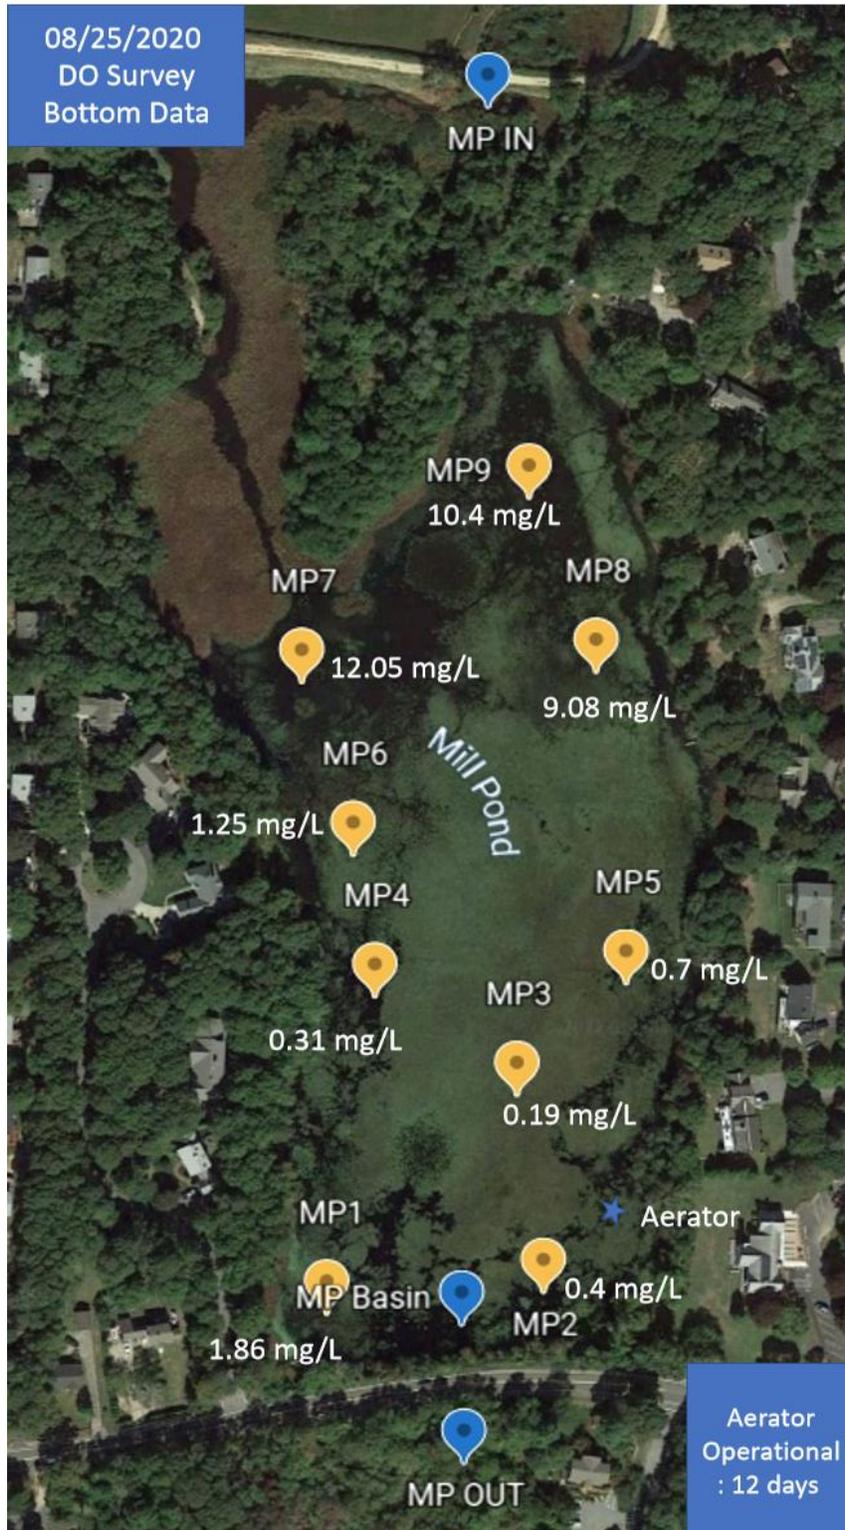
Figure III-3. In correspondence with Table III-1, each survey point is included with a focus on the bottom DO measurements for 8/25/2020 after the aerator had been running continuously for 11 days. There was no discernable effect of the aerator on general pond DO levels. The recording DO sensors were placed at the “Basin” site.

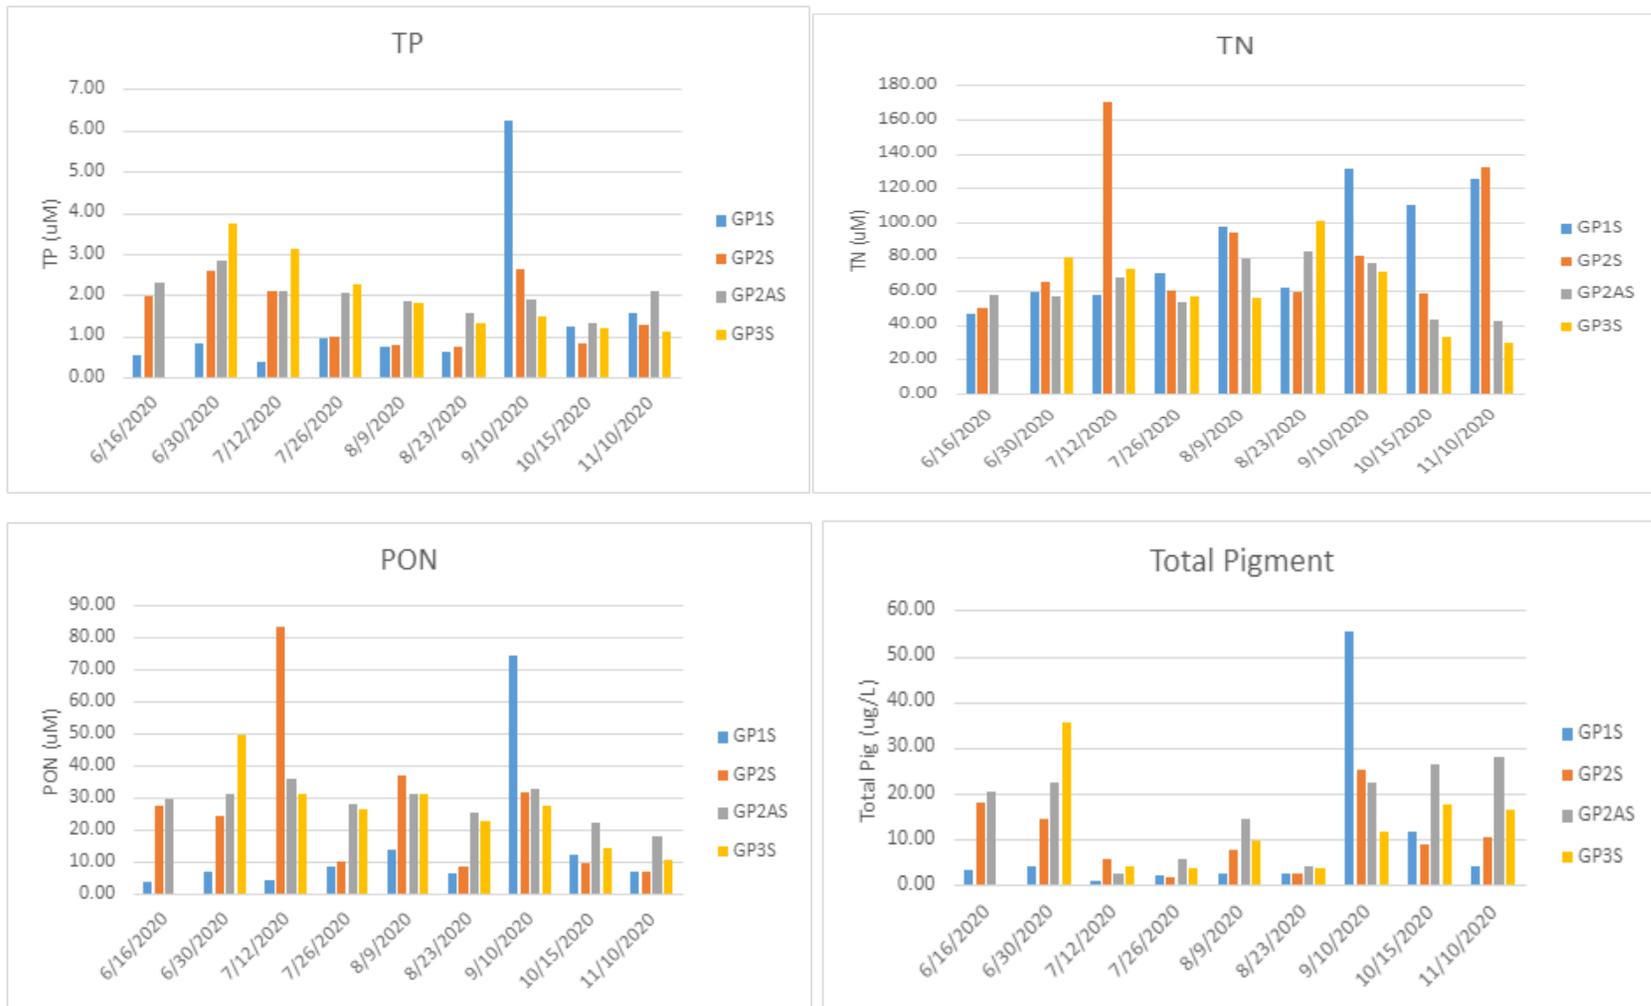
Figure IV-2. Green Pond surface concentrations for total phosphorus (TP), total nitrogen (TN), particulate organic nitrogen (PON), and total chlorophyll pigments (Total Pig). Stations listed from head to mouth of Green Pond, Falmouth.

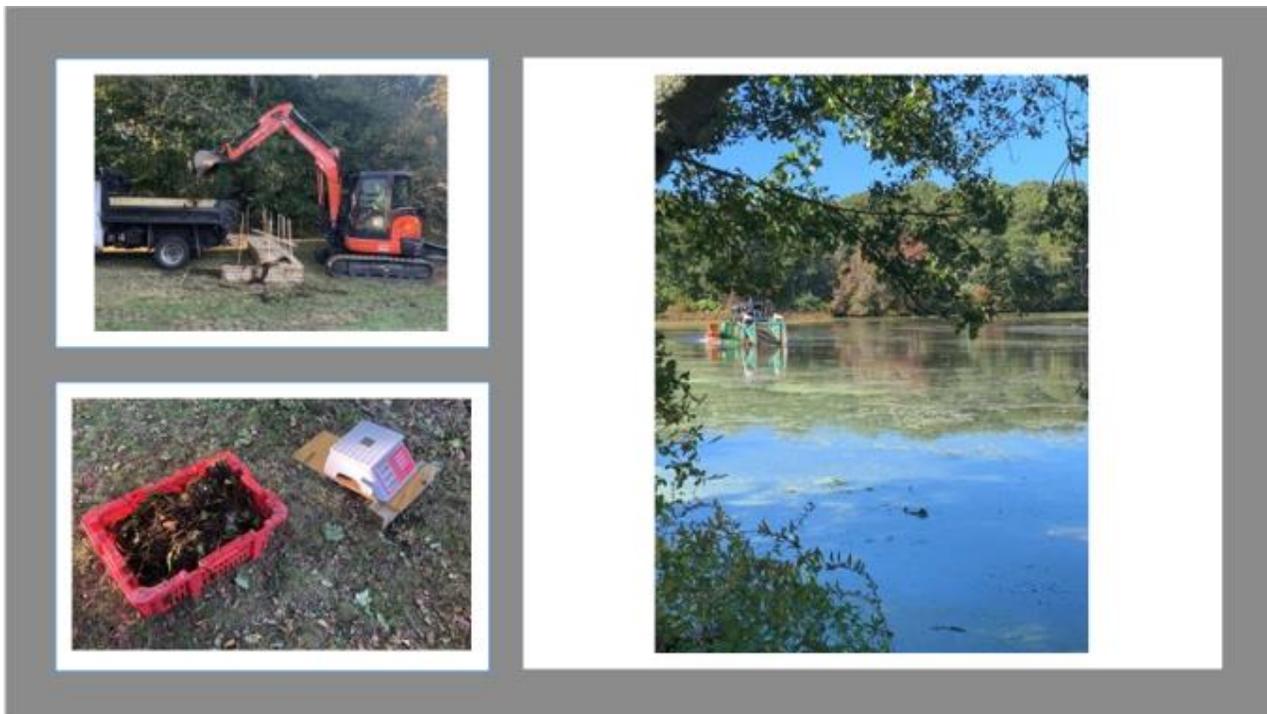
Figure VI-1. Macrophyte Harvest equipment and subsample.

Macrophyte harvest began in early October 2020 where plants were pulled from Mill Pond using a harvester (see Figure VI-1), dewatered (left to drain) overnight, and loaded into trucks to be weighted at Cape Cod Aggregates Corp. From these trucks subsamples were collected and weighted for wet weight in the field. These were then dried and ground to be analyzed. These samples were processed for % nitrogen and % phosphorus content at the time of macrophyte harvesting (see Task 4 for analysis details). The total removal of wet plant material from Mill Pond, during harvest, was 10,777kg. The wet weight ratio is 12.1 and the harvested dry weight removed was calculated as 890.7kg.
