University of
Massachusetts
Dartmouth

Technical Memorandum

RE: Response to Buzzards Bay Coalition August 23 Comment Letter on CSP/SMAST
Herring Brook Marsh assessment

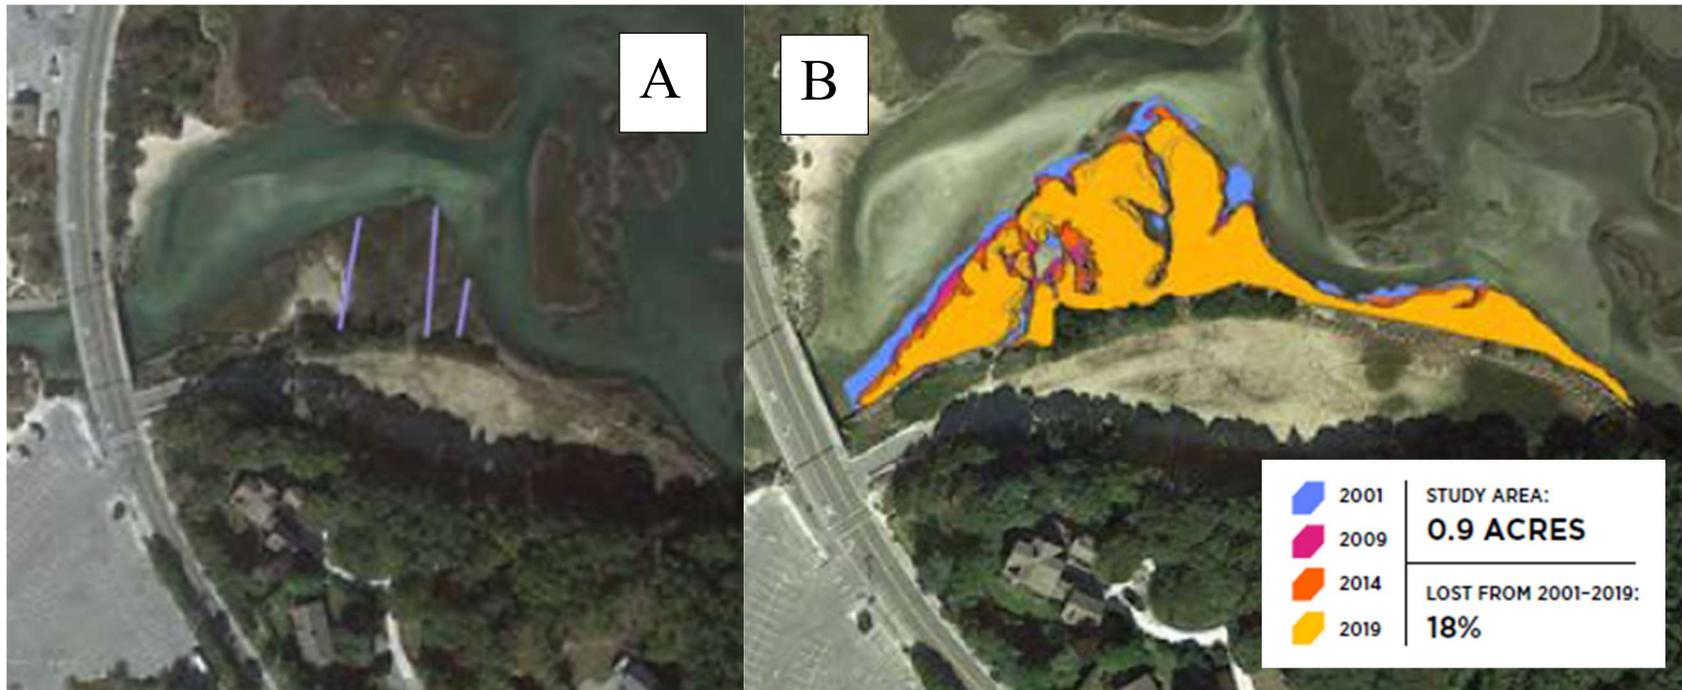
Figure 1. BBC Herring Brook Marsh Assessment Area (from Jakuba and others, 2023). BBC delineated transects in a number of salt marsh systems and the interpretation of historical aerial photographs determined that Herring Brook has lost the most salt marsh of any of the systems reviewed. Closer examination of the area in Herring Brook selected for this assessment shows that it is unrepresentative of the rest of Herring Brook and subject to regular foot traffic impacts that would degrade the marsh and be unrelated to watershed nutrient loading. The left aerial map (A) shows the transects (purple lines) used by BBC for the assessment of salt marsh loss between 2001 and 2019. As noted in the text, this area is regularly stressed by people walking across the surface of the marsh to reach the main channel of Herring Brook. The extent of foot traffic has worn away any salt marsh vegetation and created a large area of sand. Review of Google Earth aerial photographs show that this sand area has been present since at least 1995. In addition, the interpretation of aerial photos by BBC that indicates that most of the salt marsh loss has been along the northern edge of the transect area (B), does not consider that this marsh is exposed to higher tidal velocities than the rest of the Herring Brook Marsh. These higher velocities would create physical, rather than nutrient, stress on the marsh edge and they would also make this area unrepresentative of the rest of Herring Brook Marsh. Overall, review of the details of this study area suggests extrapolation to the rest of the marsh system is not supported and the characterization of Herring Brook Marsh as the most impaired by salt marsh loss is inaccurate.

The BBC review of the Herring Brook Marsh is based on three transects within a 0.9 acre area of a 27.5 acre marsh. The three transects extend from the parking area just to the east of the inlet to the main inlet stem of Herring Brook under the Quaker Road bridge (**Figure 1**). We noted that the transect area includes an area of degraded marsh where people appear to have regularly walked across the top of the marsh from the parking area to the water, as well as a 130 ft long revetment that armors the embankment that extends east from the bridge (**Figure 2**). The regular degradation in this 0.9 ac area by foot traffic would appear to make it a poor choice to be representative of the rest of the 27.5 acre marsh.

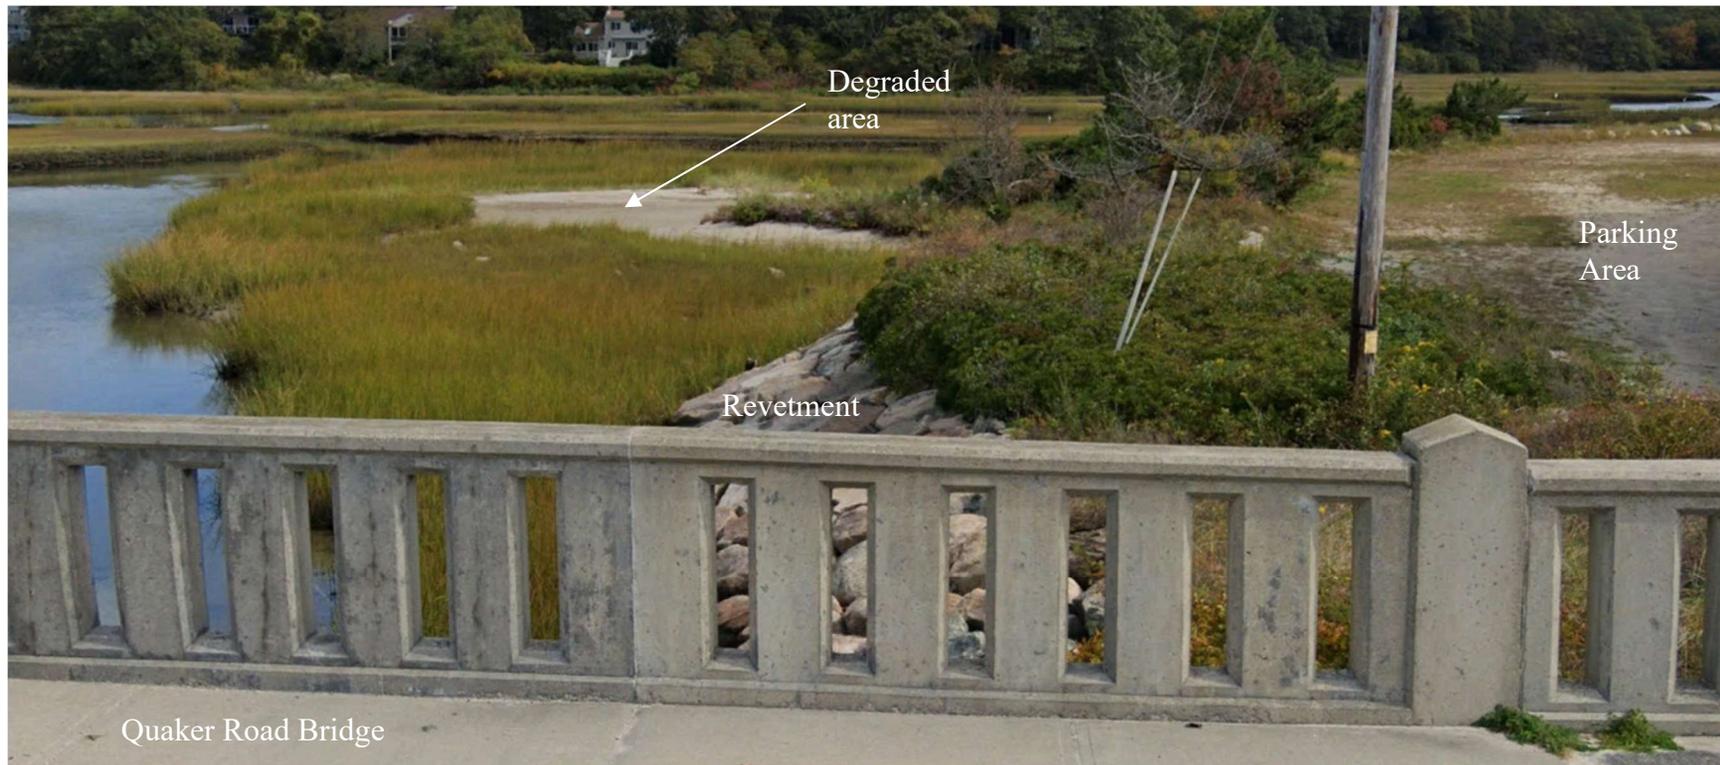
Figure 2. Google Earth Road View of Area of BBC Herring Brook Transects (October 2019 image). The photo shows the parking area on the right, the area of the salt marsh that has been degraded by people regularly walking across the surface of the marsh in the center, and a portion of the revetment that extends along the edge of parking lot ~130 ft from the edge of the bridge. The area of the BBC salt marsh transects includes a portion of the degraded area and the area assessed for salt marsh loss includes the area from the bridge along the parking lot, including the degraded area. The extensive physical manipulations and impacts within this area are unrepresentative of the rest of Herring Brook Marsh.

Our review of available Google Earth aerials at the time of Herring Brook Assessment report preparation noted the degraded area where BBC had their transects had exposed sand since at least 1995 with a path leading to the degraded area from the eastern edge of the revetment. In addition, we noted sand that has been carried into the system near this area, which suggests higher tidal velocities than is seen in the rest of the marsh system. Higher velocities, especially as sea level rises, would tend to preferentially erode the edges of nearby marsh (*i.e.*, the areas where BBC noted most of the marsh area loss since 2001; see Figure 1). Figure V-13 in our report shows that tidal velocities near the revetment and along the edge of the selected marsh area are among the highest in the system outside of the main inlet channel between the groins/jetties. A closer review of the BBC review shows much of the loss of marsh in the area is along this high velocity section of the marsh study area. In contrast to these changes, our review of available aerial photos shows that the bulk of the marsh area of the system appears to be relatively stable since 1995.

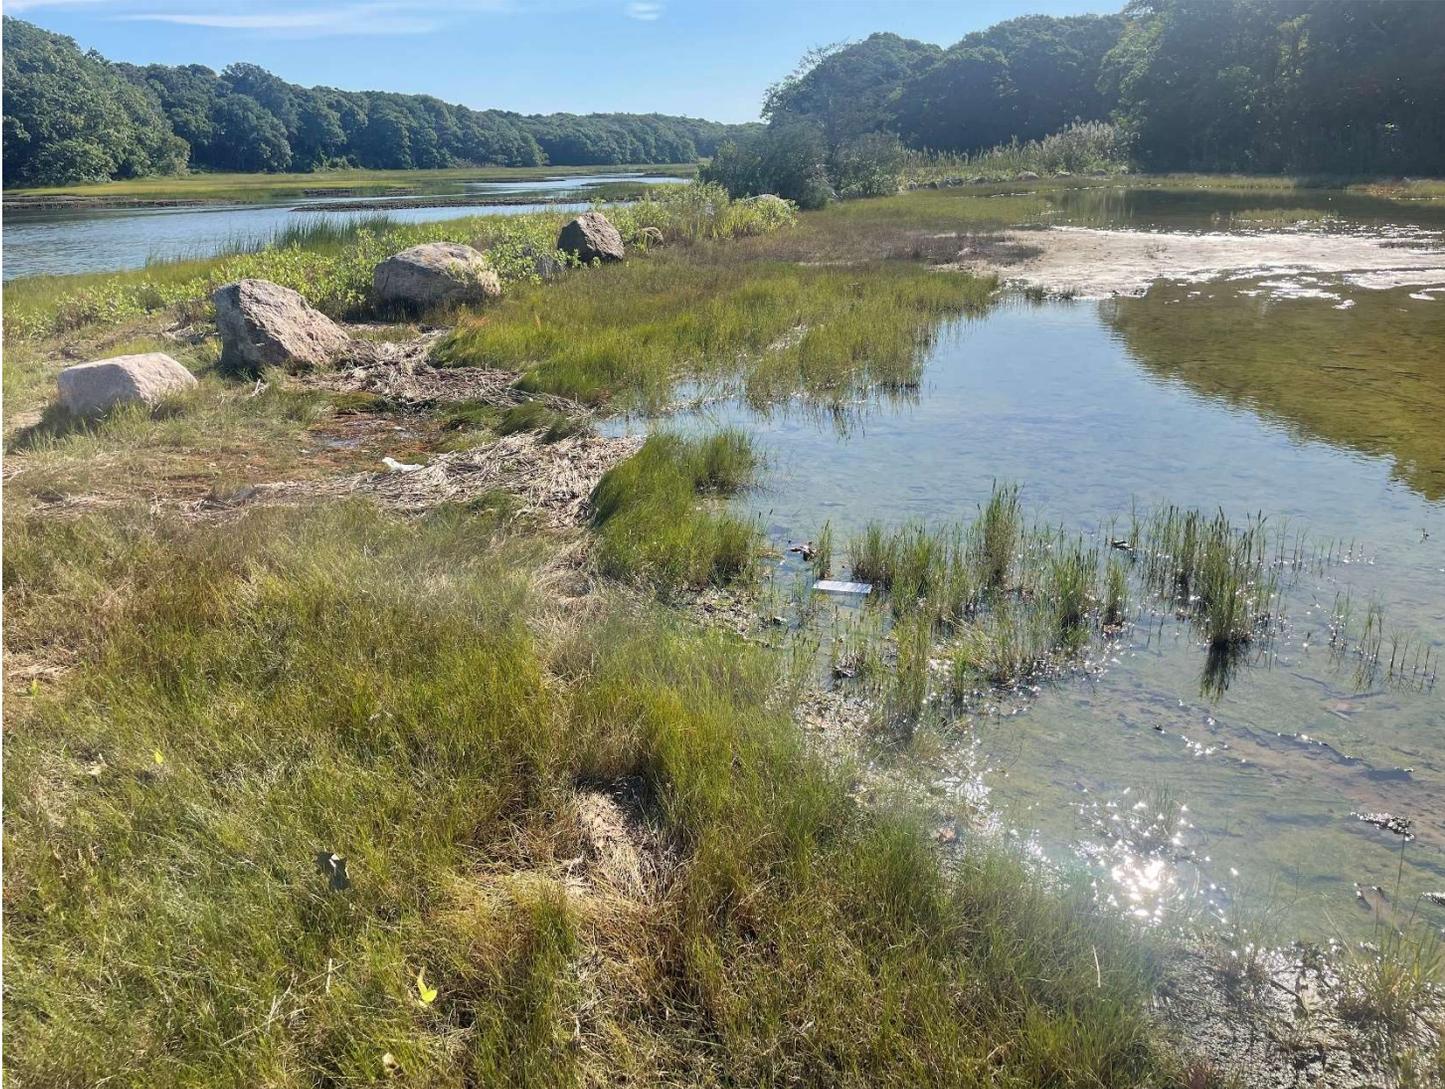
Figure 3. Herring Brook Parking Lot: Marsh Expansion (September 2023). Photograph showing the low-lying eastern portion of the Herring Brook parking lot that is inundated at high spring tides and contains extensive areas of salt marsh. This 'new' salt marsh expansion area is a direct result of ongoing sea level rise and indicates that the marsh is migrating due to rising sea levels and expanding into new areas not included in the BBC or Tobias review.

In addition, a recent visit to BBC assessment area shows that the landward side of the marsh edge is increasing by migrating into the parking area under the influence of sea level rise (**Figure 3**). Dr. Tobias relied on the BBC assessment results, but site visit show that if BBC researchers had extended the original transects landward, the results would illustrate the gradual landward migration of salt marsh into the low-lying area of the eastern portion of the parking lot. Based on this landward migration of the marsh, it is likely that there actually has been an increase in salt marsh acreage in in the area BBC shows there has been marsh loss.
