Re: Request for Committee's Support of Article 6 Amendment

Timeline Comparison: Discharge TASA to Herring Brook v. Discharge all to Ocean Outfall

BUZZARDS BAY
SALT MARSHES:

Vulnerability and Adaptation Potential

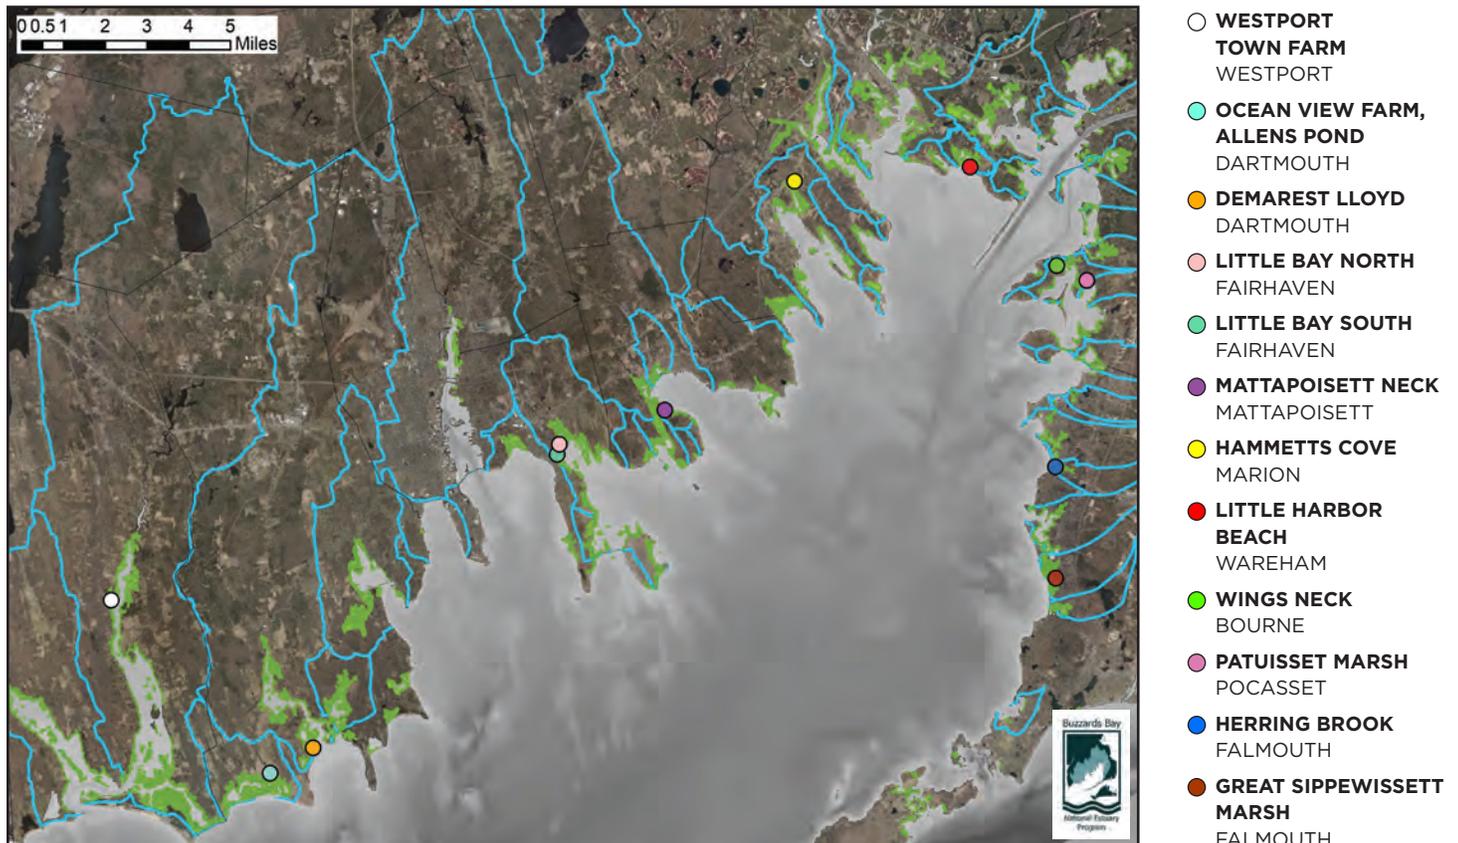
Map shows salt marsh area shaded in green, watershed boundaries in blue, and long-term monitoring sites as colored dots. Source: Bureau of Geographic Information (MassGIS), Commonwealth of Massachusetts, Executive Office of Technology and Security Services and Buzzards Bay National Estuary Program.

The Buzzards Bay Coalition and the Buzzards Bay National Estuary Program began field monitoring of salt marshes around Buzzards Bay in 2019 to document changes (map below shows sites). We partnered with the U.S. Geological Survey and the Woodwell Climate Research Center to use aerial tools to investigate how different characteristics of the long-term marsh sites and their watersheds affect the marsh's current health and likely future. This report brings together the results of on the ground monitoring with data from aerial imagery to look at marsh status at 12 long-term monitoring sites based on existing stressors, current marsh conditions, and potential for adaptation.

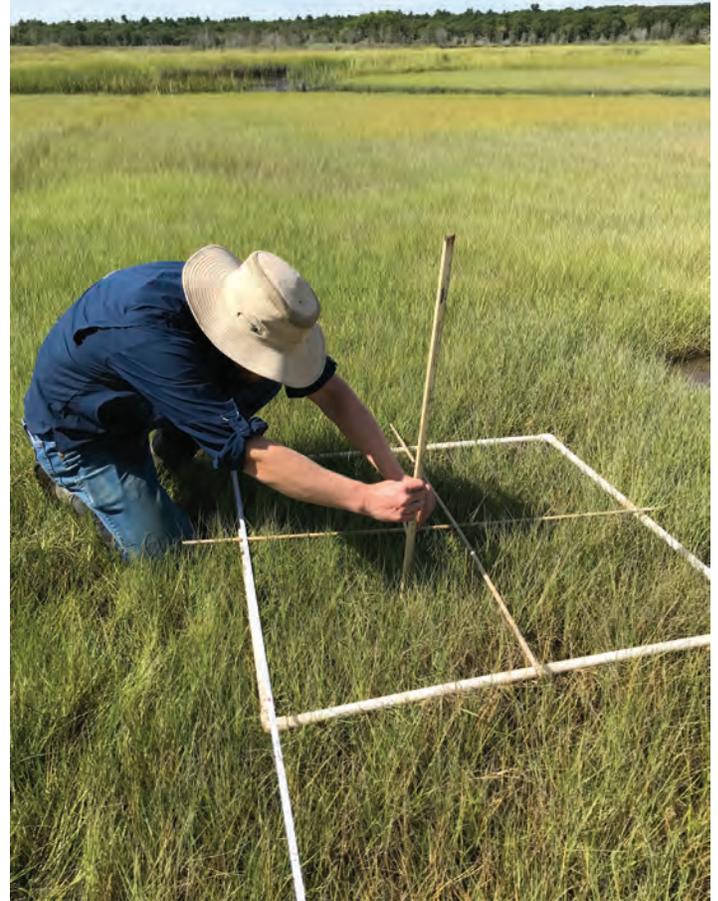
Summer field technician Ryan Kappel measures stem height at a monitoring quadrat at the Mattapoisett Neck site.

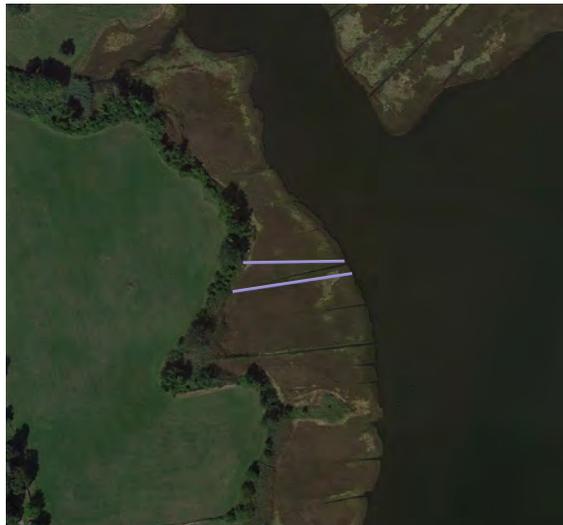
Site map showing transects where on the ground measurements were made. Created with Google Earth.

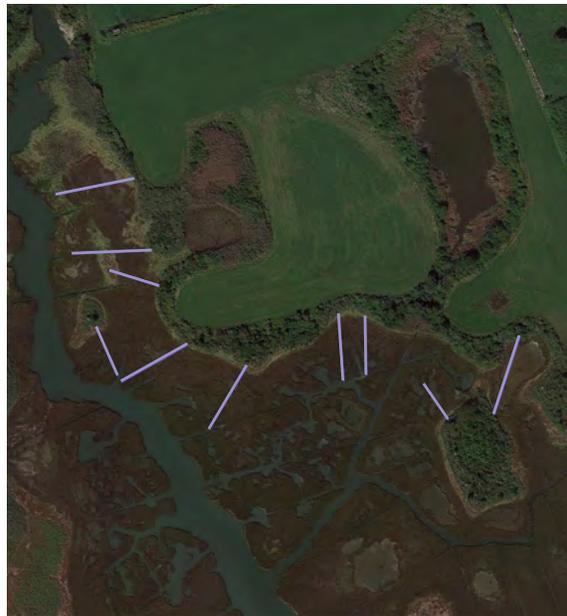
Site map showing transects where on the ground measurements were made. Created with Google Earth.

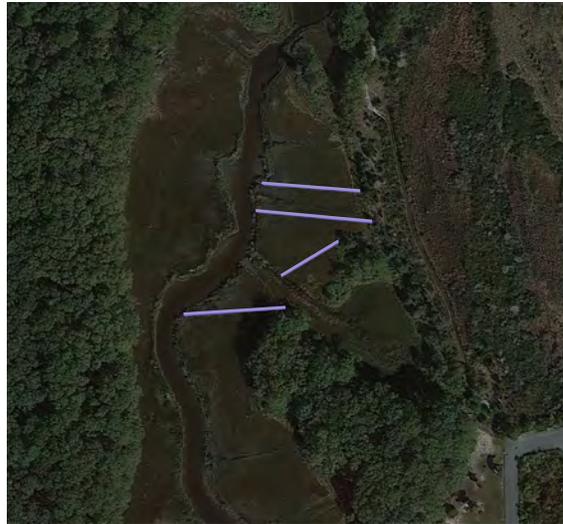
Site map showing transects where on the ground measurements were made. Created with Google Earth.

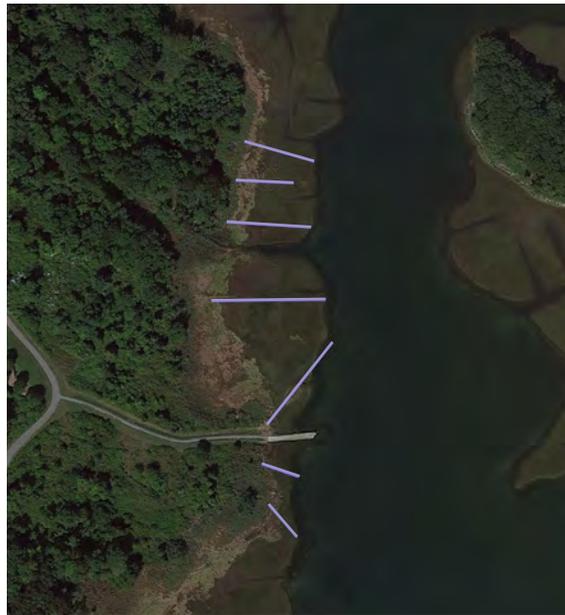
Site map showing transects where on the ground measurements were made. Created with Google Earth.

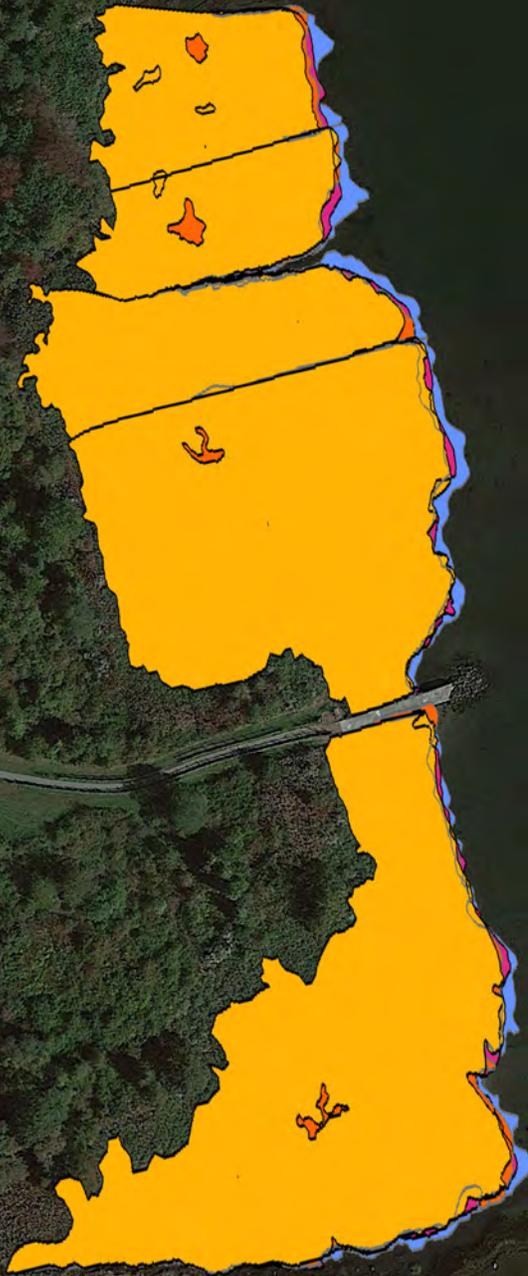
Site map with marsh area in different years shown by shaded regions. Blue, pink, and orange shading indicate areas that were previously vegetated marsh but were bare in 2019. Created with Google Earth.

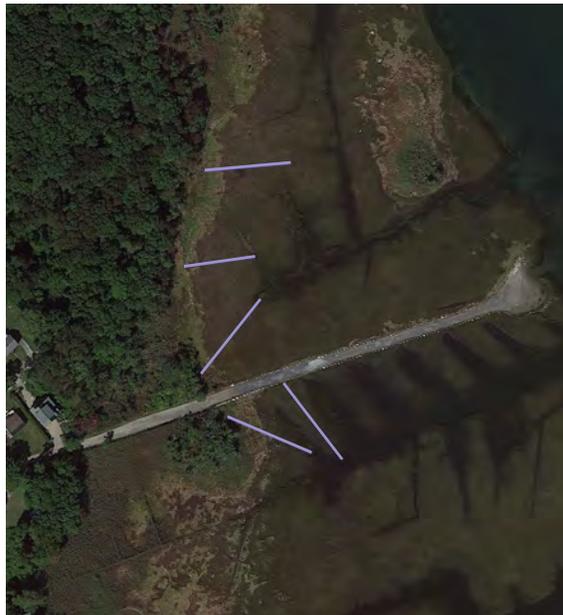
Site map showing transects where on the ground measurements were made. Created with Google Earth.

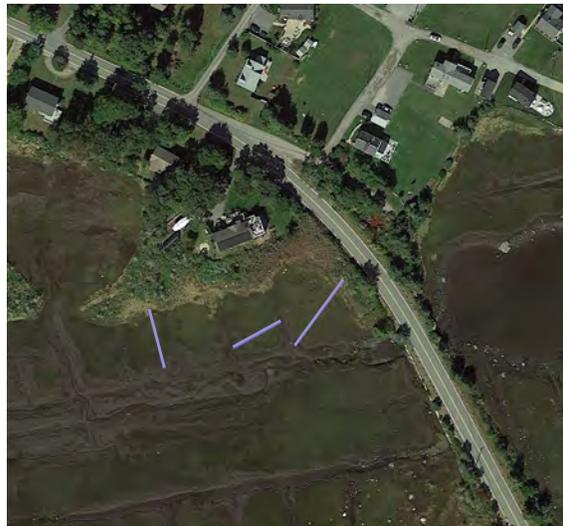
Site map showing transects where on the ground measurements were made. Created with Google Earth.

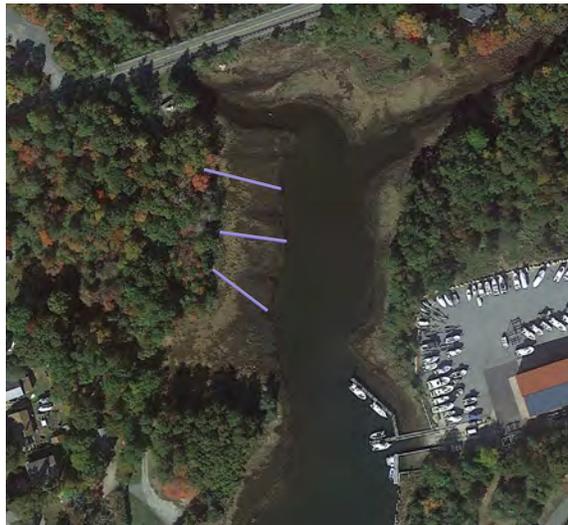
Site map showing transects where on the ground measurements were made. Created with Google Earth.

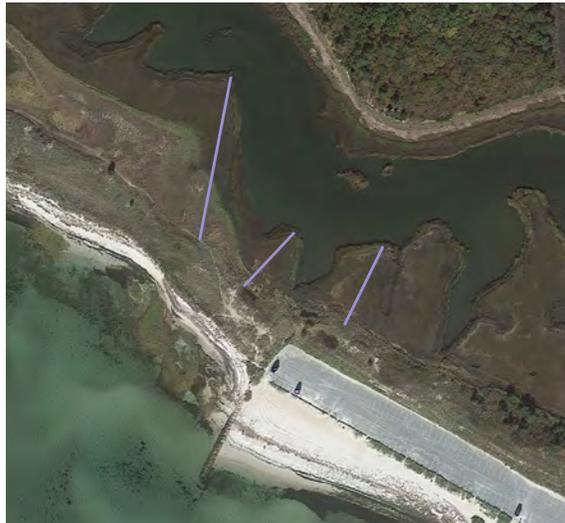
Site map showing transects where on the ground measurements were made. Created with Google Earth.

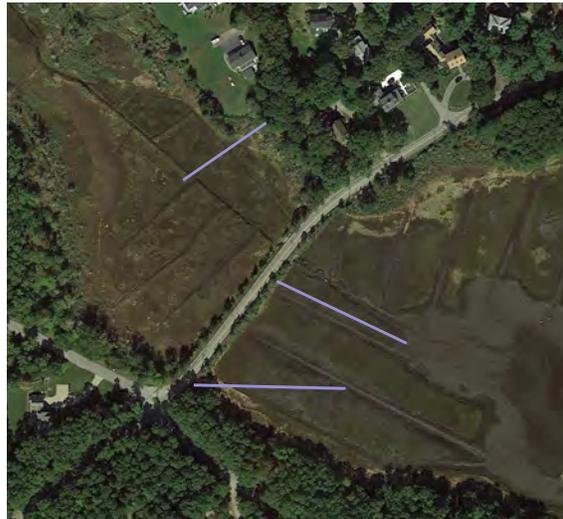
Site map showing transects where on the ground measurements were made. Created with Google Earth.

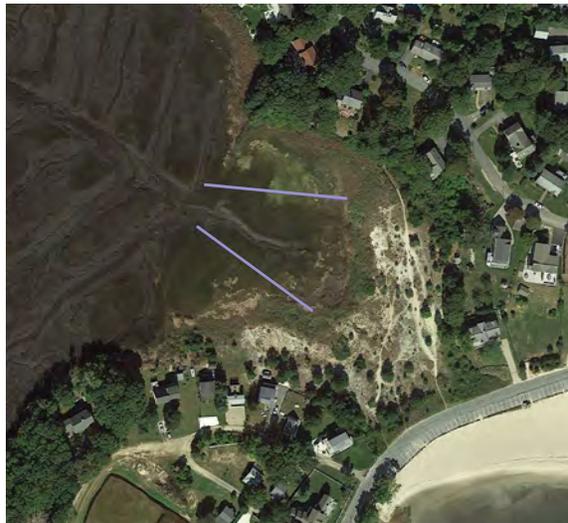
Site map showing transects where on the ground measurements were made. Created with Google Earth.

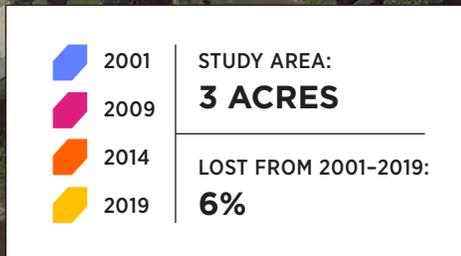
Site map with marsh area in different years shown by shaded regions. Blue, pink, and orange shading indicate areas that were previously vegetated marsh but were bare in 2019. Created with Google Earth.

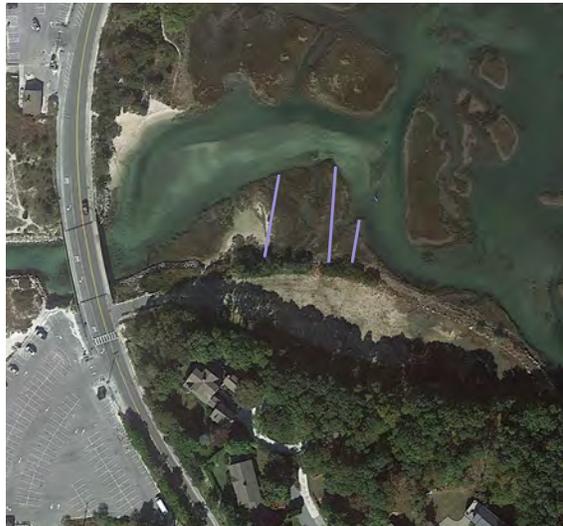
Site map showing transects where on the ground measurements were made. Created with Google Earth.

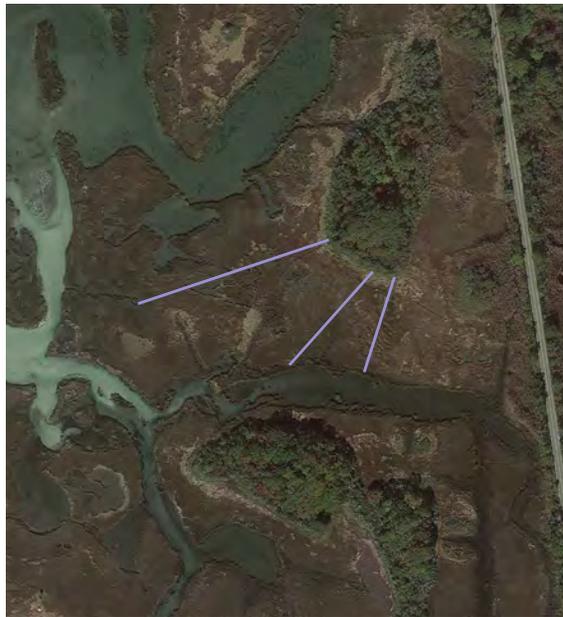
Site map showing transects where on the ground measurements were made. Created with Google Earth.
