**2026 BEACH  
MANAGEMENT PLAN**

6 Introduction..... 1

14     Megansett Beach..... 7

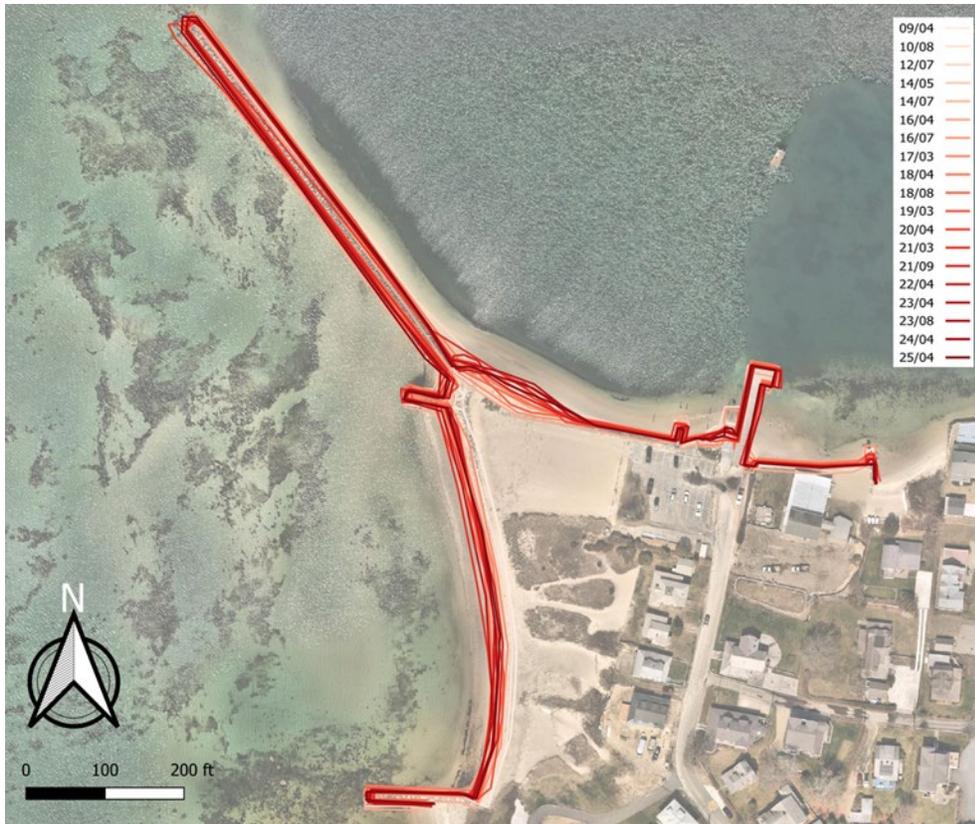
351 University of the Philippines as a QGIS equivalent to DSAS, a USGS developed shoreline  
352 analysis toolbox (QSCAT, 2024). Figure 4 presents the blocked averages resulting from the  
353 QSCAT shoreline analysis.

355 *Figure 4: Shoreline Change from 2009 to 2025 – Megansett Beach.*

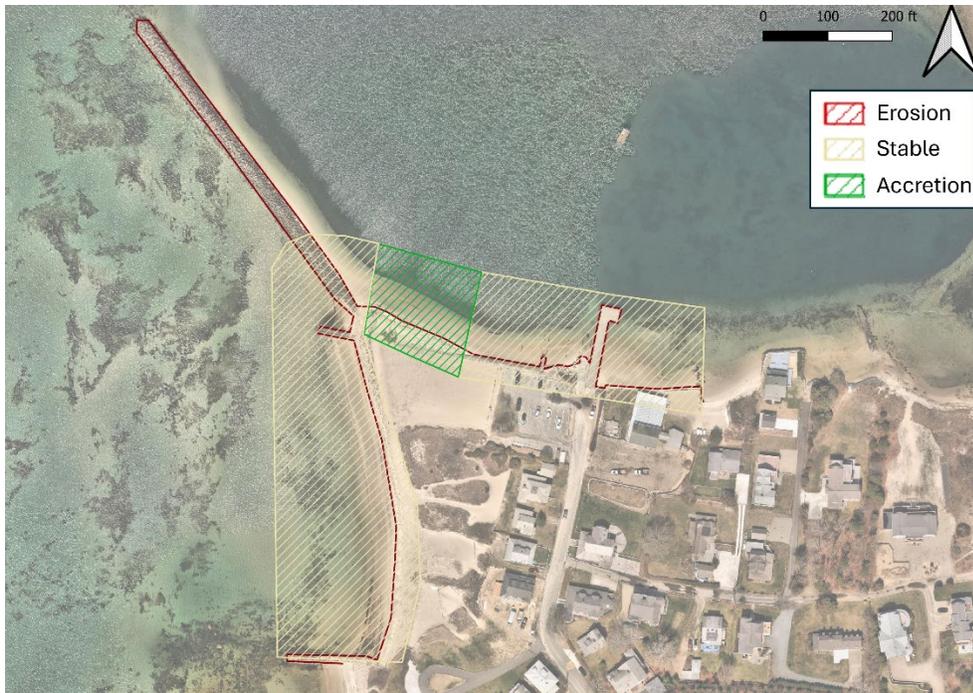
356 QSCAT blocked averages are presented as erosional, stable, or accretional for this  
 357 analysis. Megansett Beach is characterized as stable to accretional for the study period.

361 *Figure 5: Erosion/Accretion Pattern at Megansett Beach.*

362 The same stable/accretional pattern can be observed from DEM data, shown in Figure 5 in  
 363 select profiles. Available DEM data for this area includes the years 2011, 2014, and 2021.  
 364 Seven (7) profile transects were extracted for analysis. This DEM dataset provides a  
 365 valuable baseline that can be used for comparison with more recent survey data  
 366 collections. Available DEM data generally extends to mean low water or slightly deeper.  
 367 Survey data extending farther offshore into deeper water is recommended to assess cross-  
 368 shore sediment transport trends.

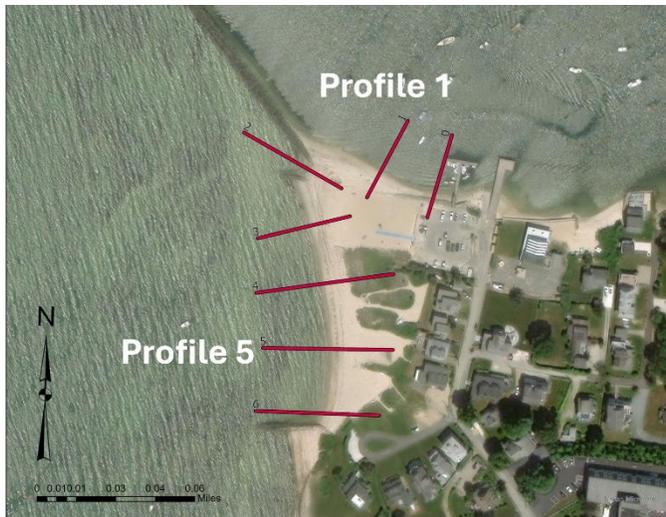
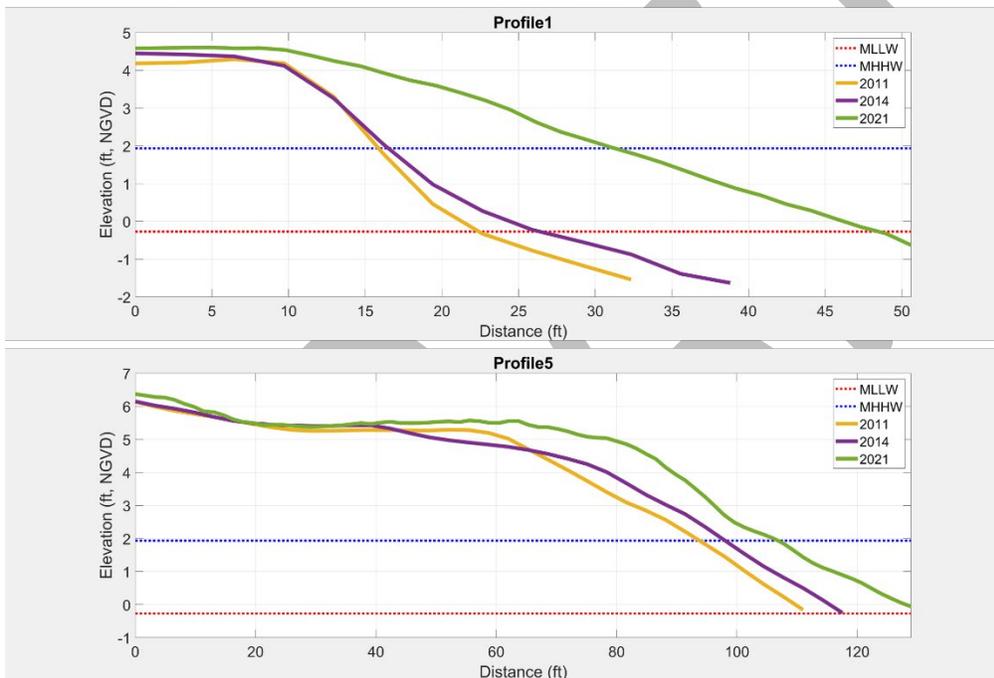
370 *Figure 6: Profiles from DEMs, Megansett Beach.*

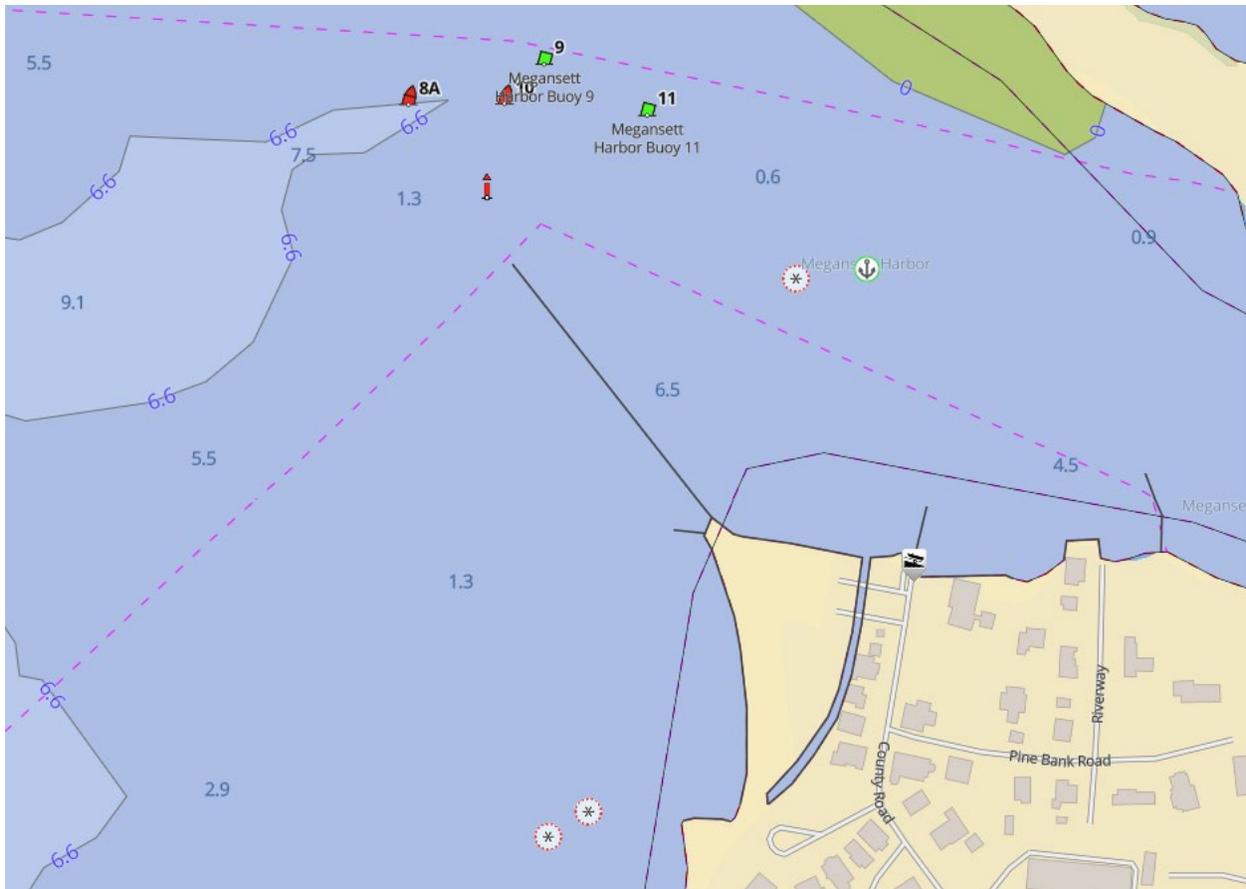
371 Figure 7 presents a navigation chart overview of the Megansett Beach area. Shallow areas  
 372 extend over 500 feet to the west-facing shoreline while a deeper harbor area is located just  
 373 offshore to the north-facing shoreline.

375 *Figure 7: Navigation Chart Excerpt of Megansett Beach (Depths in Feet MLW)*

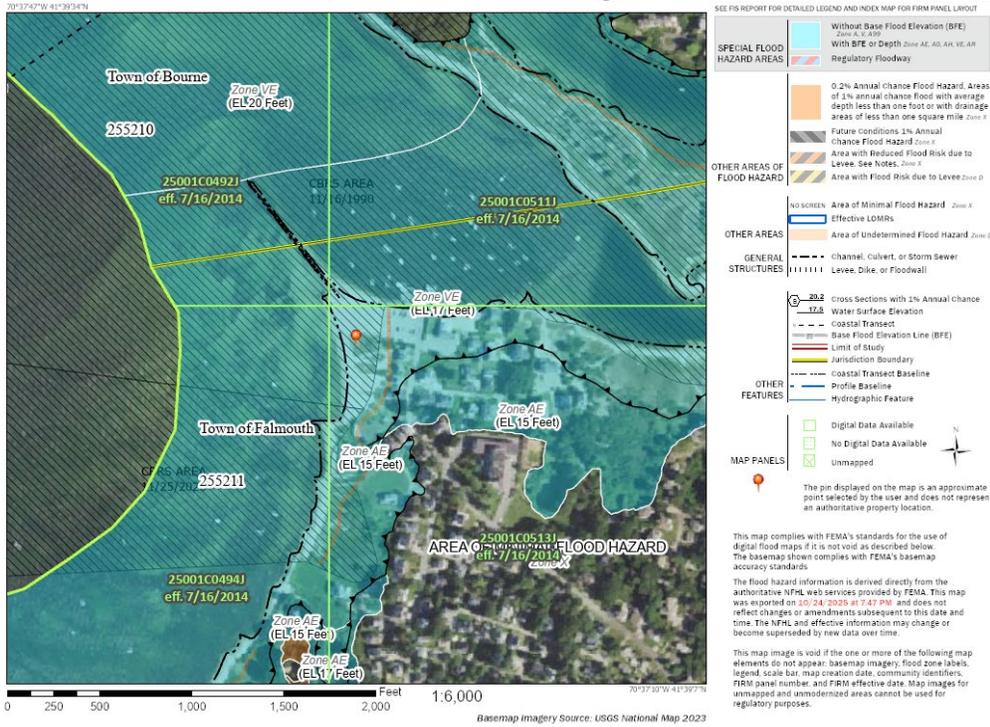
379 Under 100-year storm surge conditions, all beach areas in VE zones (where wave heights  
 380 are greater than 3 feet) will be inundated. The beach systems studied in this analysis  
 381 generally feature narrow upper beach areas and will experience significant erosion during  
 382 a 100-yr storm event. The dune systems are also generally narrow and will experience  
 383 significant erosion (or even complete dune removal) during a 100-yr storm event.

385 *Figure 8: FEMA FIRMette of Megansett Beach. Effective 07. 16. 2014.*

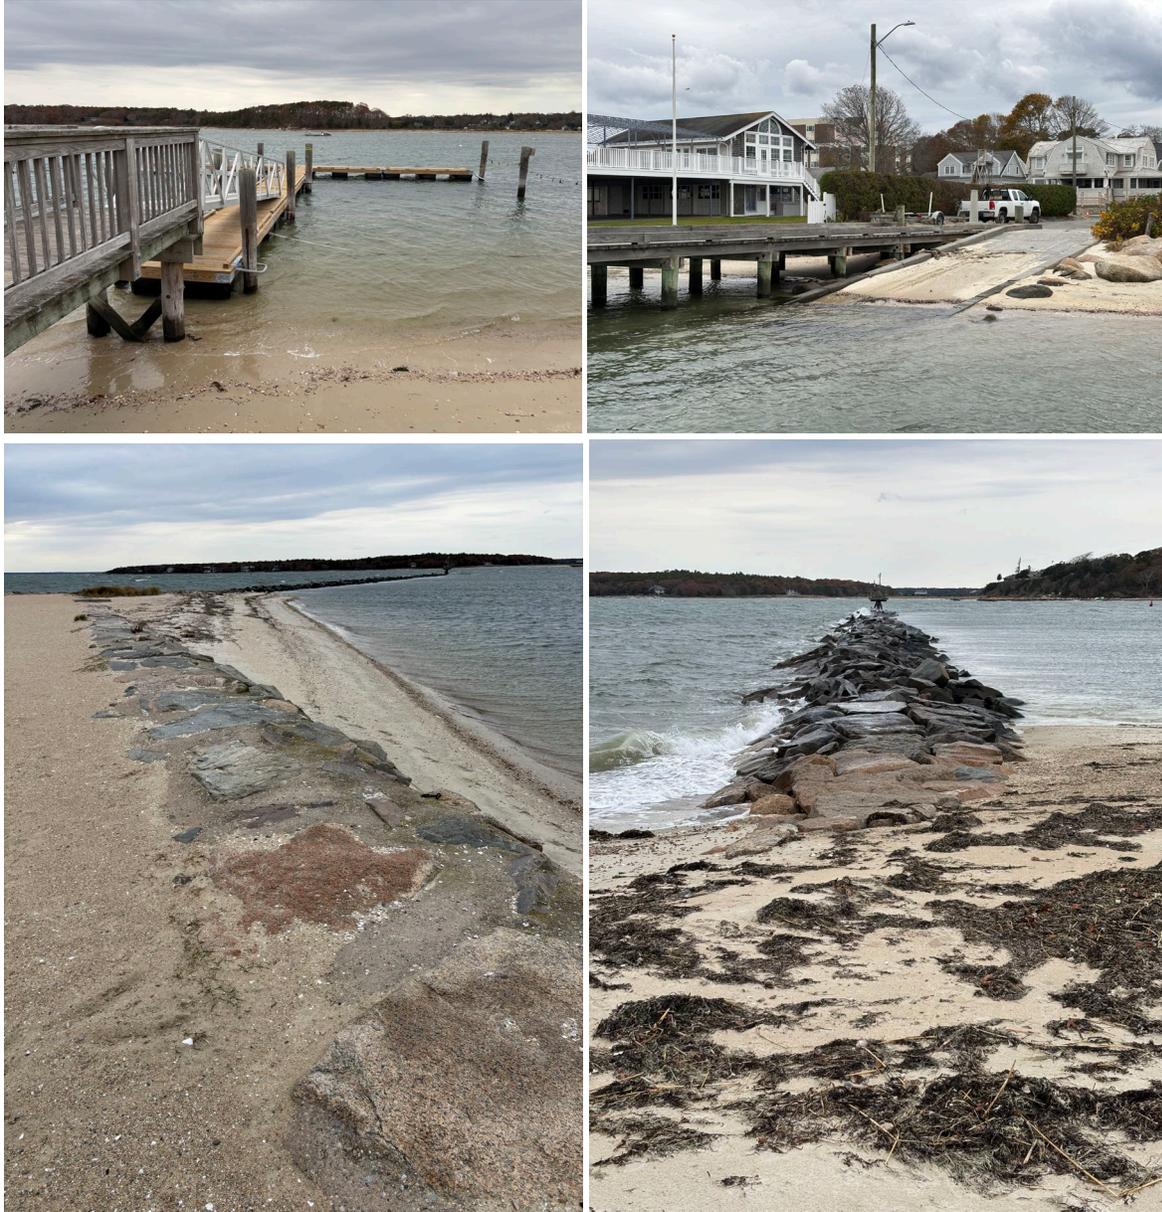
398  
399 *Figure 9: Dock (upper left), boat ramp (upper right), rock revetment (lower left), and jetty (lower right) at Megansett Beach.*

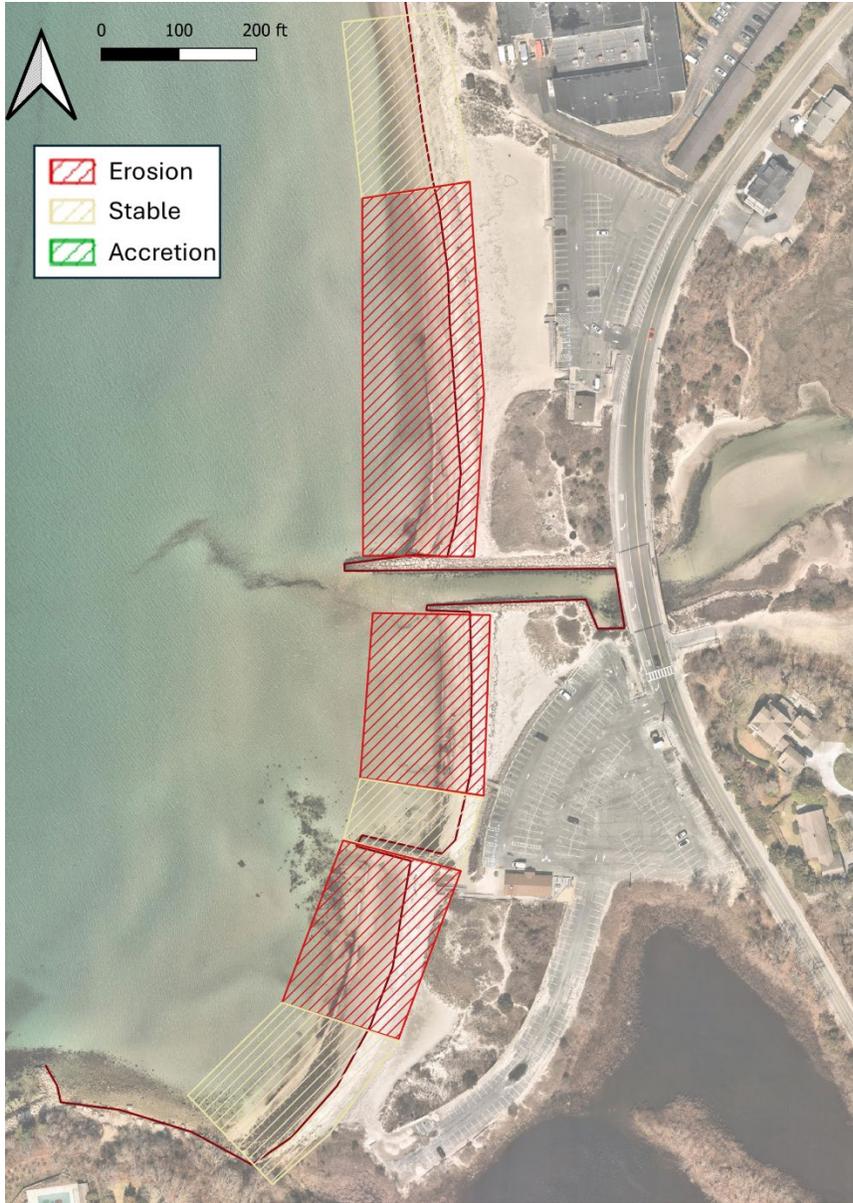
453 *Figure 15: Erosion/Accretion Pattern at Old Silver Beach.*

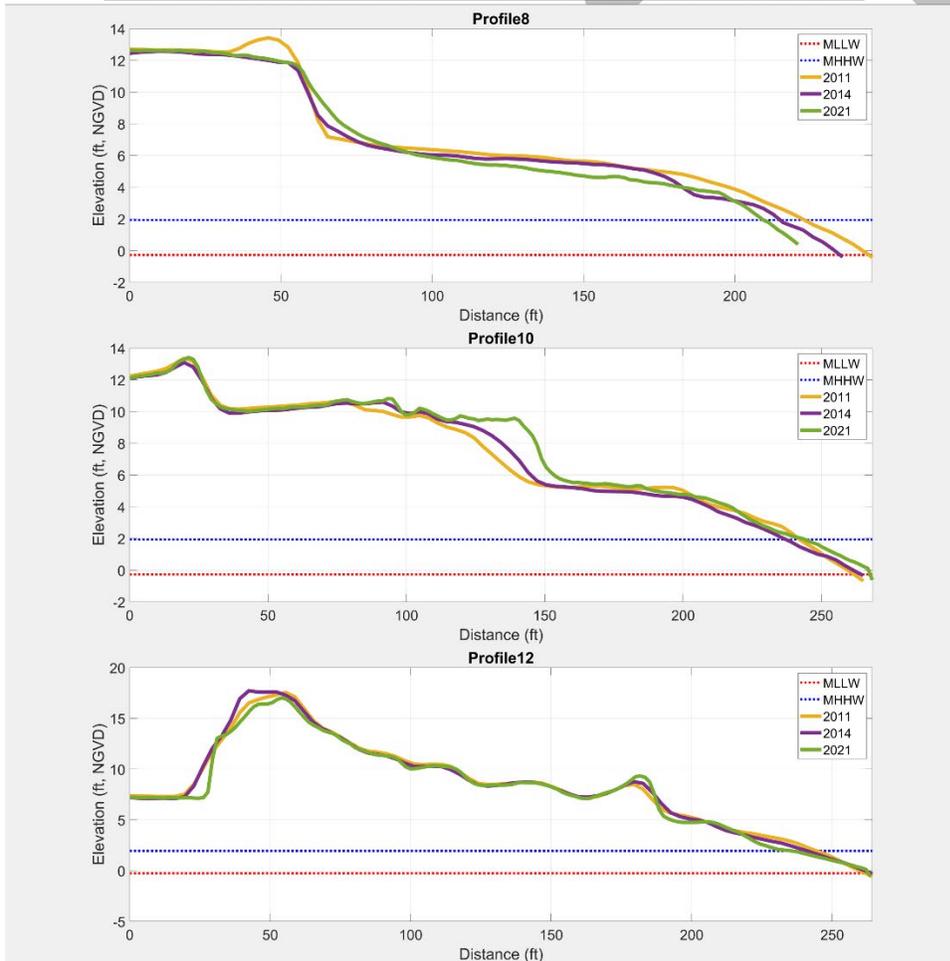
455 *Figure 16: Profiles from DEMs, Old Silver Beach.*

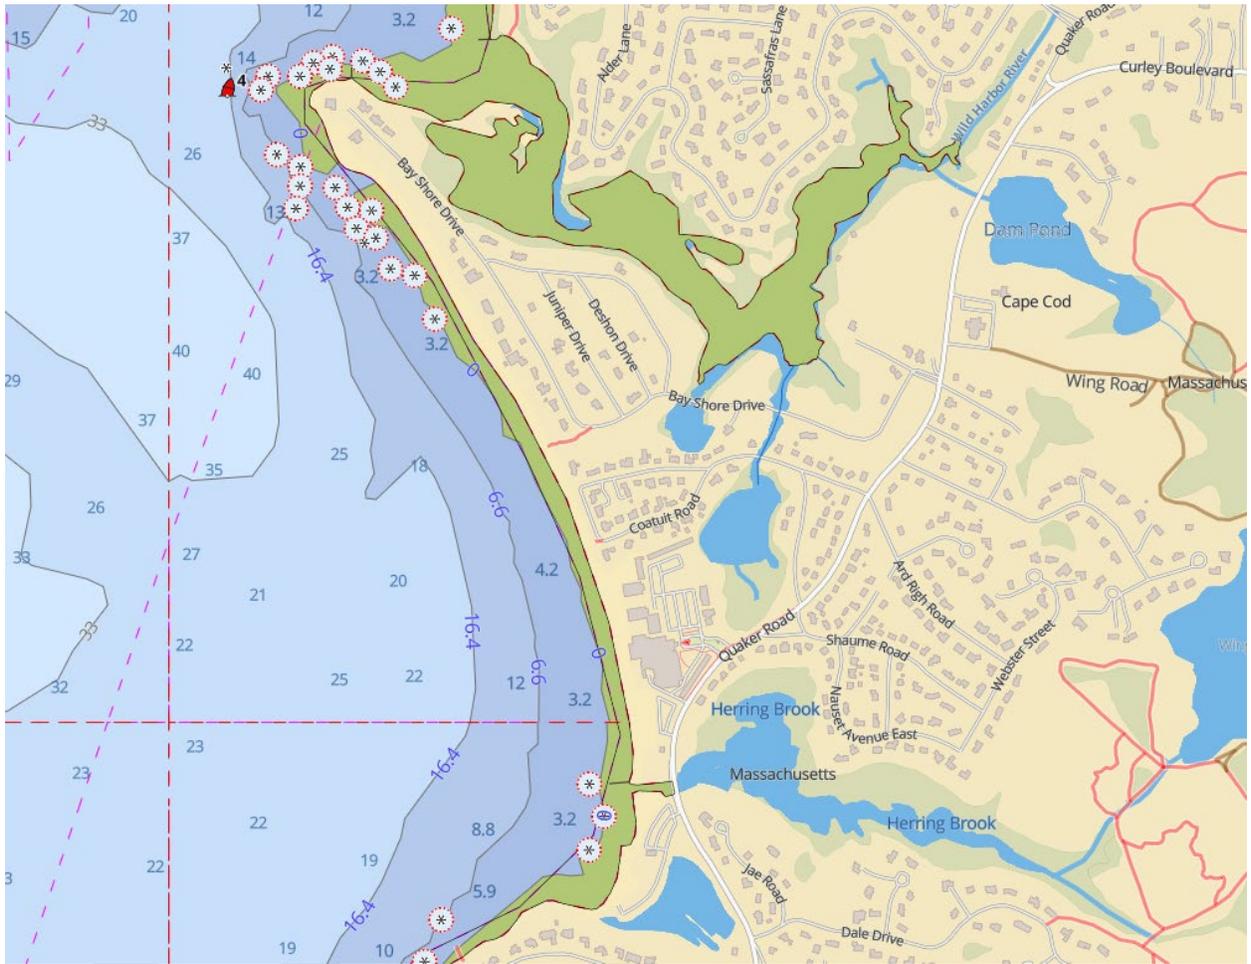
456 Figure 17 below presents a navigation chart excerpt of Old Silver Beach (depths in feet  
457 MLW). The nearshore transitions to deeper water (~20 foot depths) over ~1,000 feet.

458  
459 *Figure 17: Navigation Chart Excerpt of Old Silver Beach (Depths in Feet, MLW).*

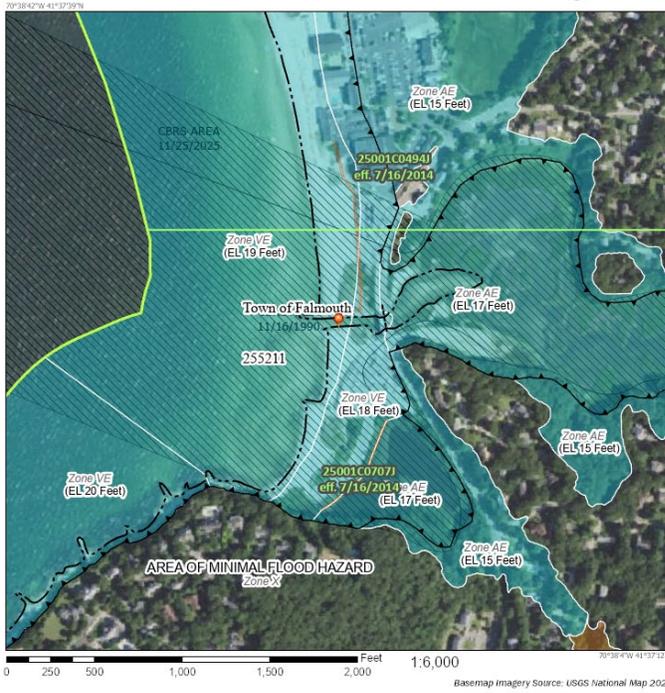
460 Figure 18 shows the current effective FIRM at Old Silver Beach (Zone VE, 18 ft BFE).  
461 Historical FIRMette of the area (1992) is shown in Figure 19 (Zone V15, 18ft BFE).

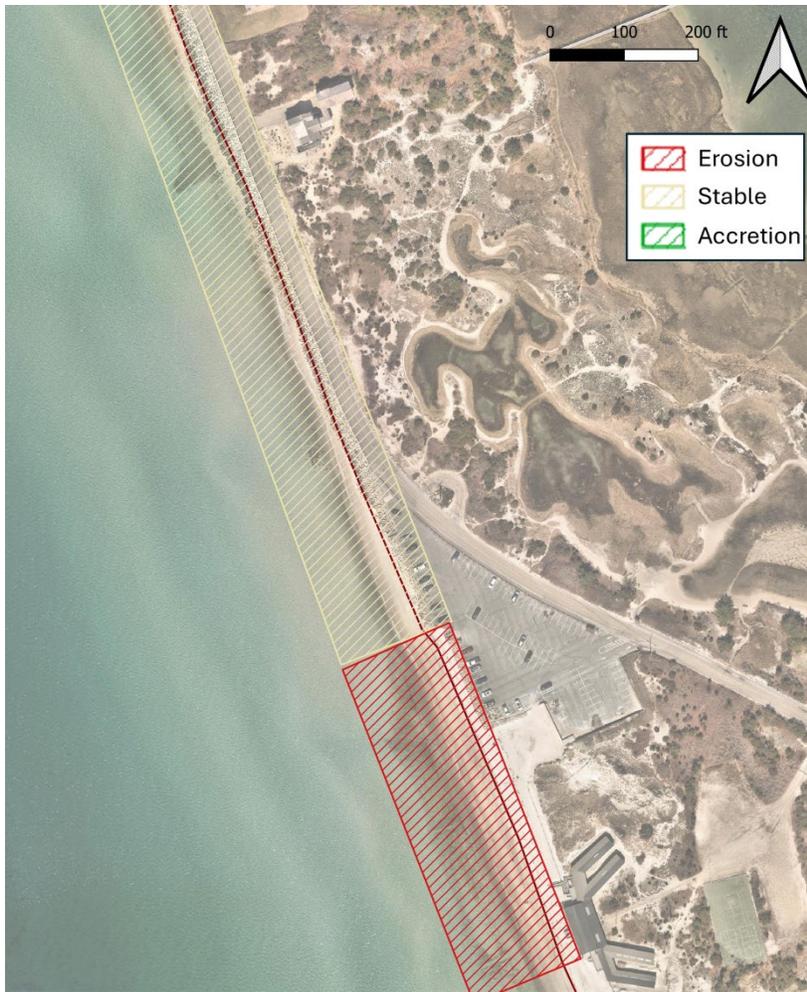
558 *Figure 30: Erosion/Accretion shoreline change pattern at Chapoquoit Beach.*

553 Figure 29 presents the shorelines used for this beach while Figure 30 presents the blocked  
554 average QSCAT results.

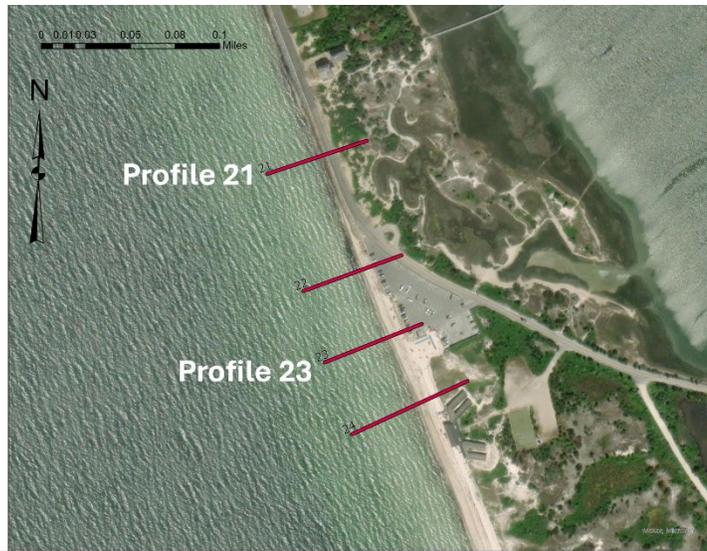
559 DEM data is shown in Figure 31. In Figure 31, Profile 21 (rock revetment) shows a typical  
 560 armored shoreline that shows little to no change in elevation. However, note that DEM data  
 561 only extends to approximate mean low water (MLW) and some deflation of the beach  
 562 profile seaward of MLW is anticipated as this is a classic nearshore response to  
 563 alongshore armoring at/near the MHW line. Profile 23 shows DEM profile erosion of the  
 564 beach up to the revetment that borders the parking lot.

566 *Figure 31: Profiles from DEMs, Chapoquoit Beach.*

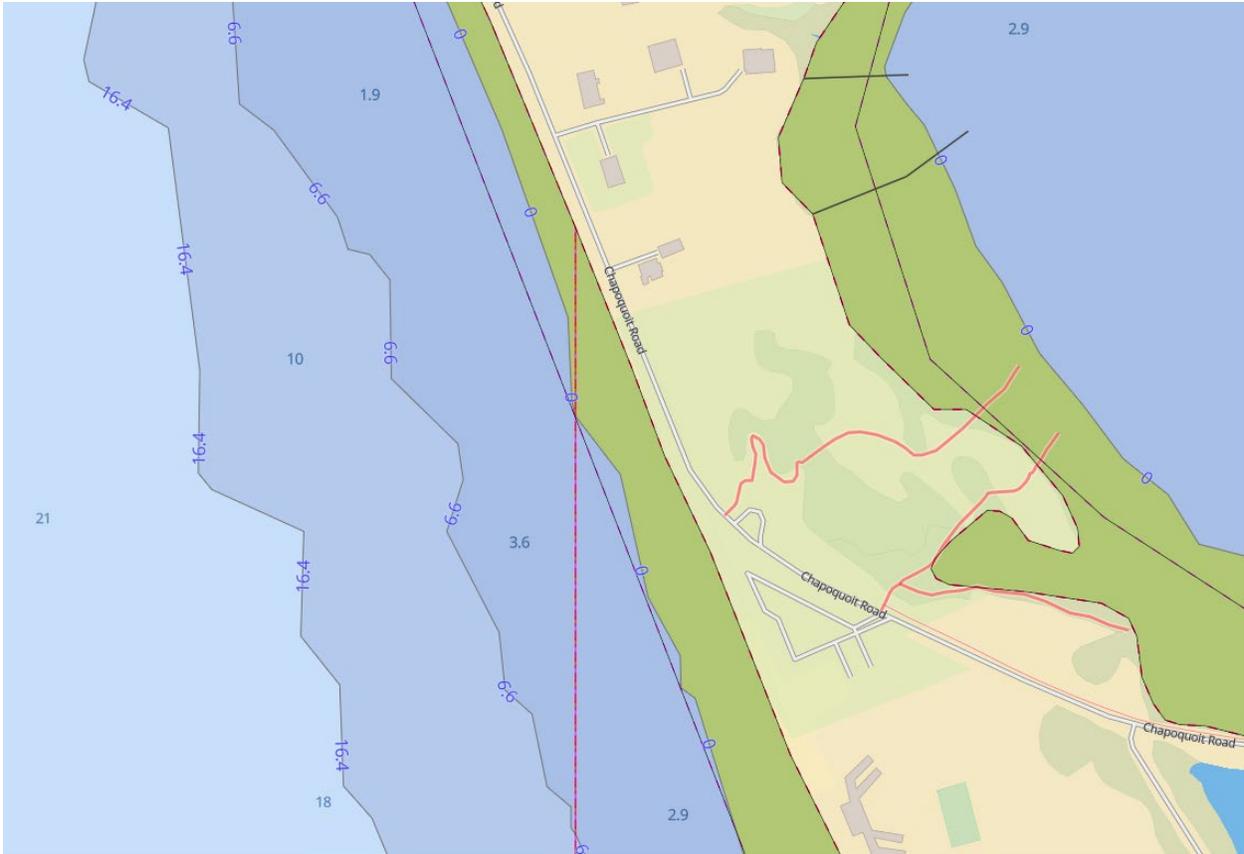
567 Figure 32 presents a navigation chart excerpt of the Chapoquoit Beach nearshore. The  
 568 beach profile in the nearshore (beyond MLW) gradually transitions to deeper water over  
 569 several hundred feet.

571 *Figure 32: Chapoquoit Beach Navigation Chart Excerpt (Depths in Feet MLW).*

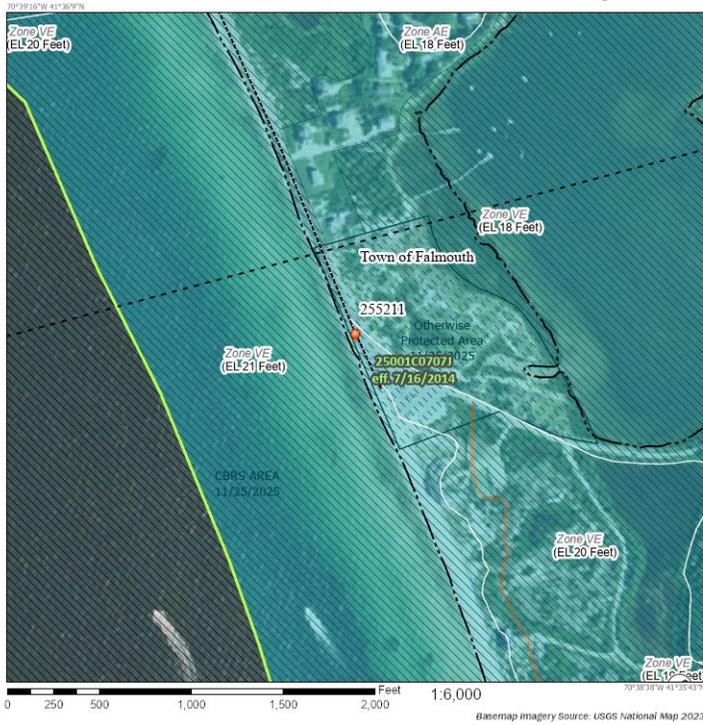
577 Figure 34: Historic FIRMette of Chapoquit Beach, 1993.

573 Historical FIRMette of the area (1993) is shown in Figure 34 (Zone V15, 22ft BFE).

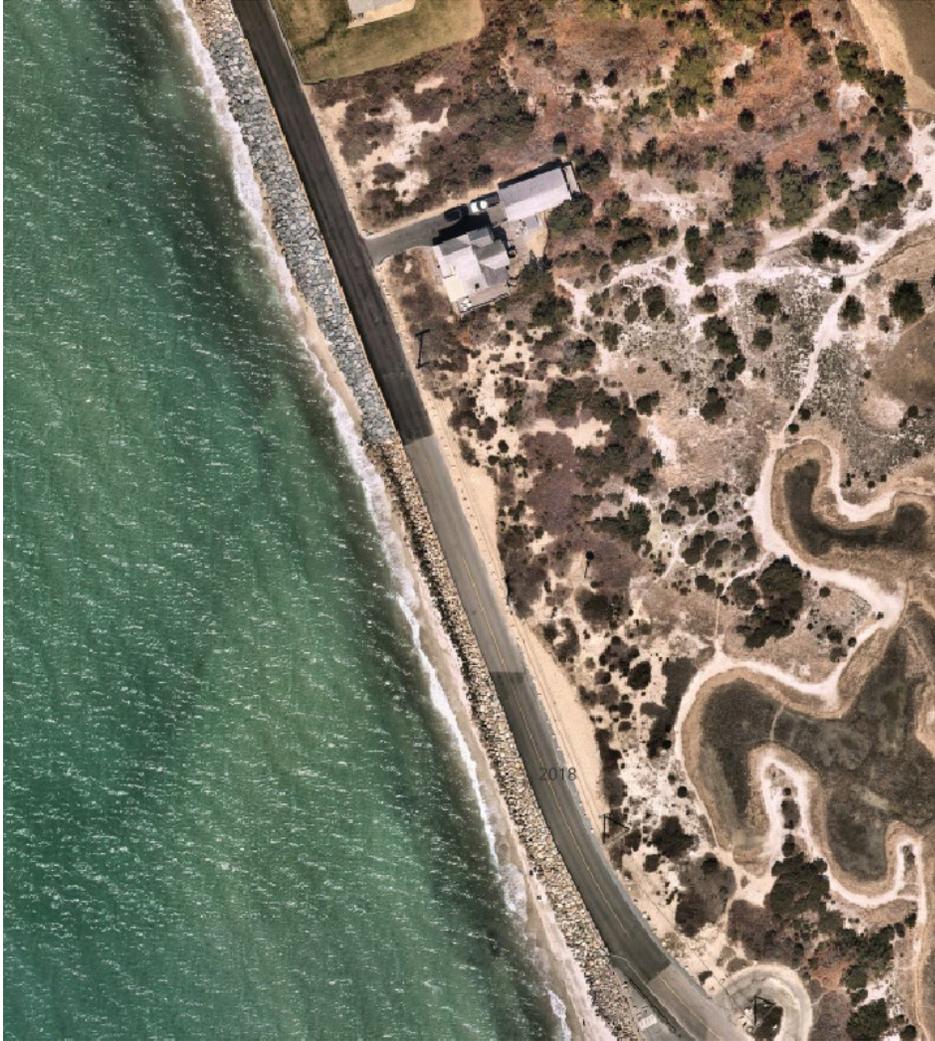
590 Sections of beach along Chapoquoit Road north of the parking lot have eroded since 2008  
591 causing voids under the roadway. New bulkheading, revetments, and repaving occurred in  
592 2018 and 2021 (Figure 36). Larger rock for the revetment was used compared to the  
593 preexisting revetment.

595 *Figure 36: New Revetment Sections, Chapoquoit Beach.*

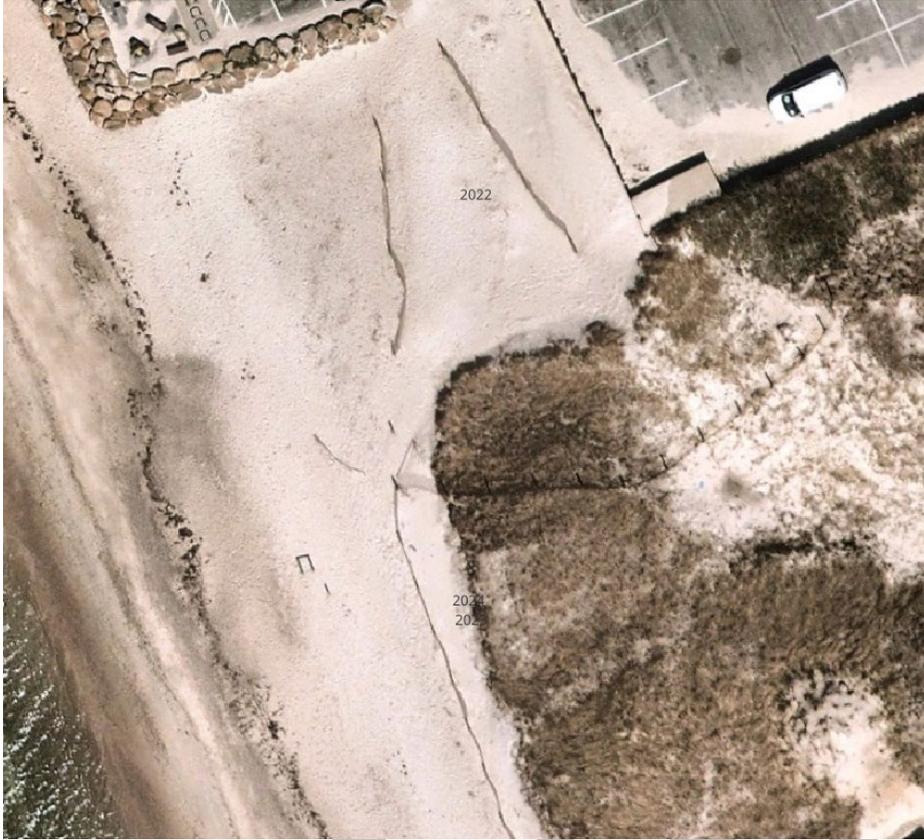
596 A seasonal sand fence is typically installed to the south of the parking lot between the rock  
597 revetment and the dunes. Configuration varies from year to year. Figure 37 presents an  
598 example layout of sand fencing.

600 *Figure 37: Sand Fence at Chapoquoit Beach.*

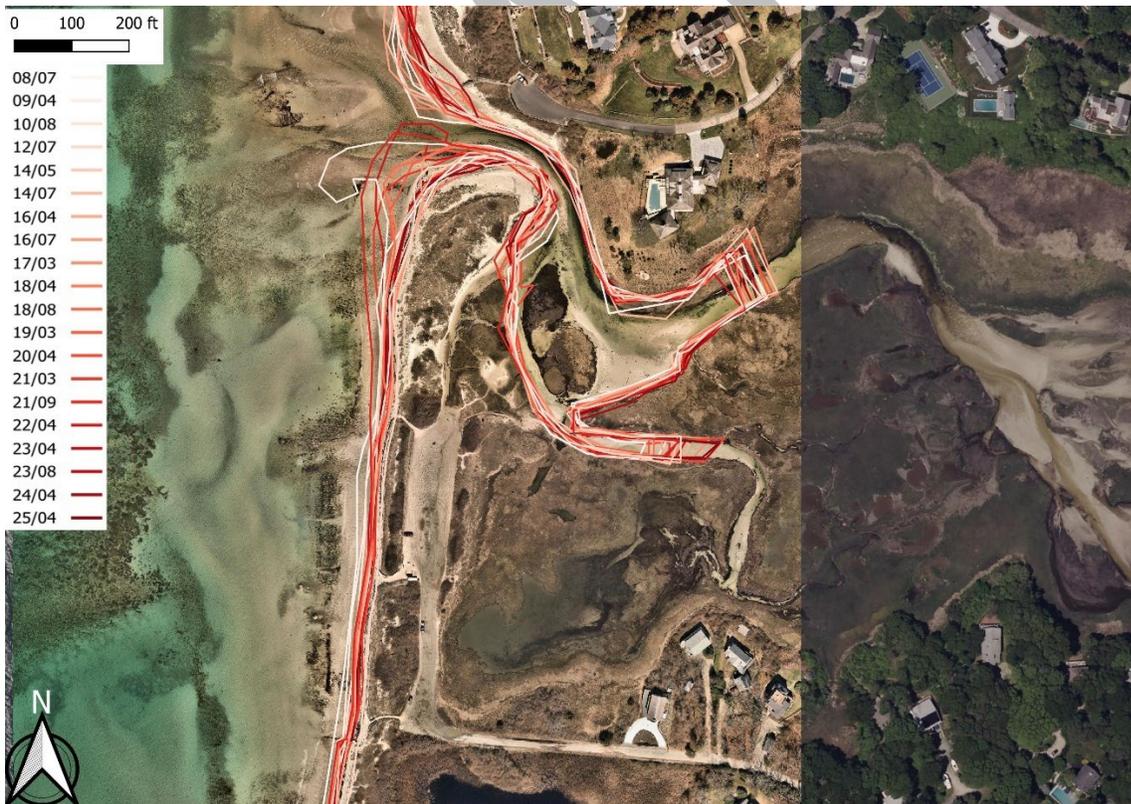
647 Wood Neck beach is affected by inlet dynamics, which is armored/revetted on the  
648 northern bank to prevent further migration. The southern bank, however, is not armored  
649 and has been much more dynamic over the years (Figure 42 and Figure 43). Figure 42  
650 presents shorelines used for the analysis and Figure 43 presents blocked average QSCAT  
651 results.

655  
656 *Figure 42: Shoreline Change from 2008 to 2025 – Wood Neck Beach.*

652 The combined effects of inlet migration with partial armoring, over the years, however, are  
653 net stable with statistically insignificant retreat. To the south of the inlet the shoreline is  
654 mostly stable.

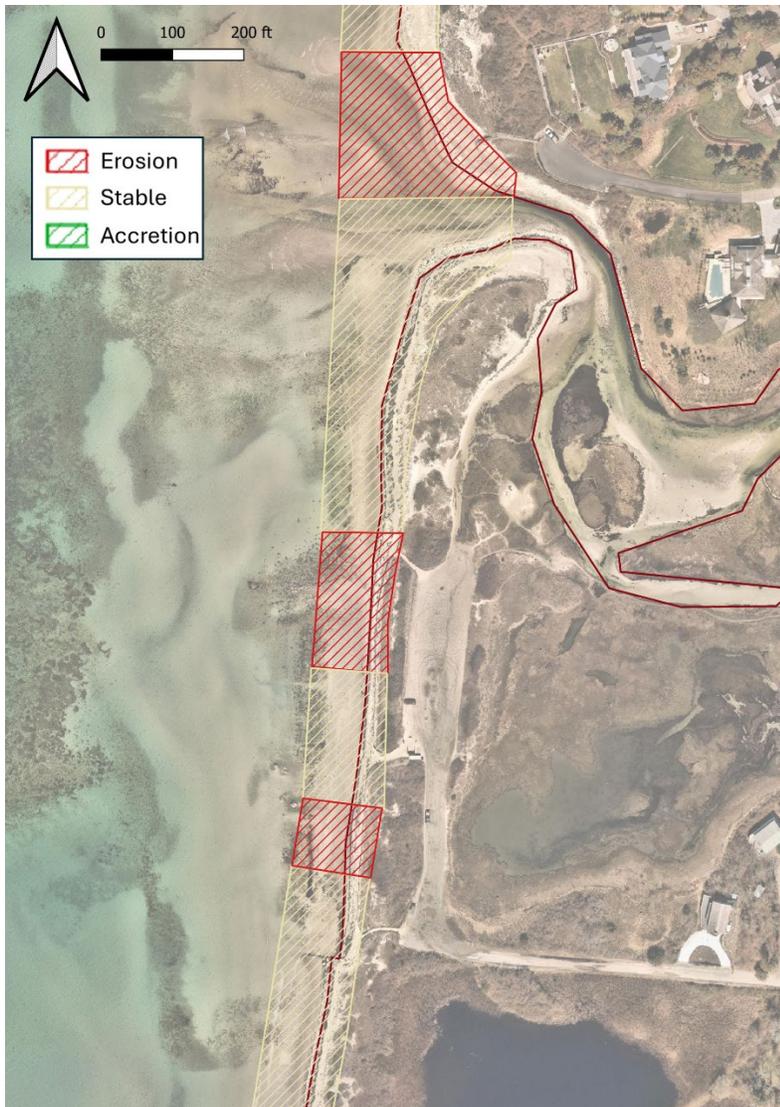
658 *Figure 43: Erosion/Accretion Pattern at Wood Neck Beach.*

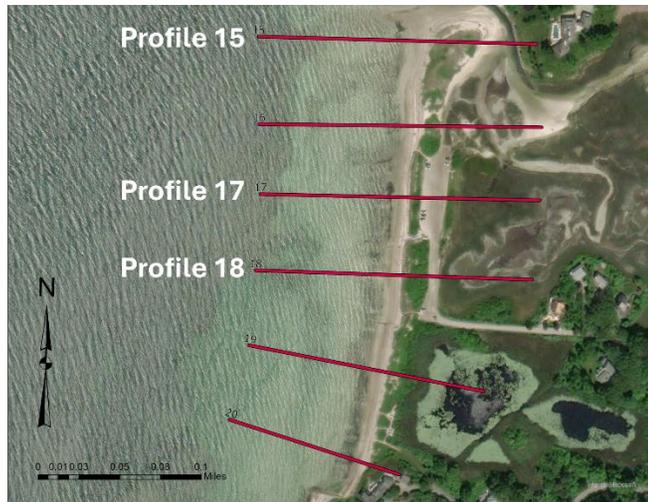
659 As expected, DEM data shows trends similar to the shoreline analysis. The section of  
 660 beach in front of the parking lot is eroding at 2 ft/yr, steepening the slope of the dune  
 661 (Figure 44, Profile 17). Note that DEM data derived from LiDAR only extends to approximate  
 662 MLW.

664 *Figure 44: Profiles from DEMs, Wood Neck Beach.*

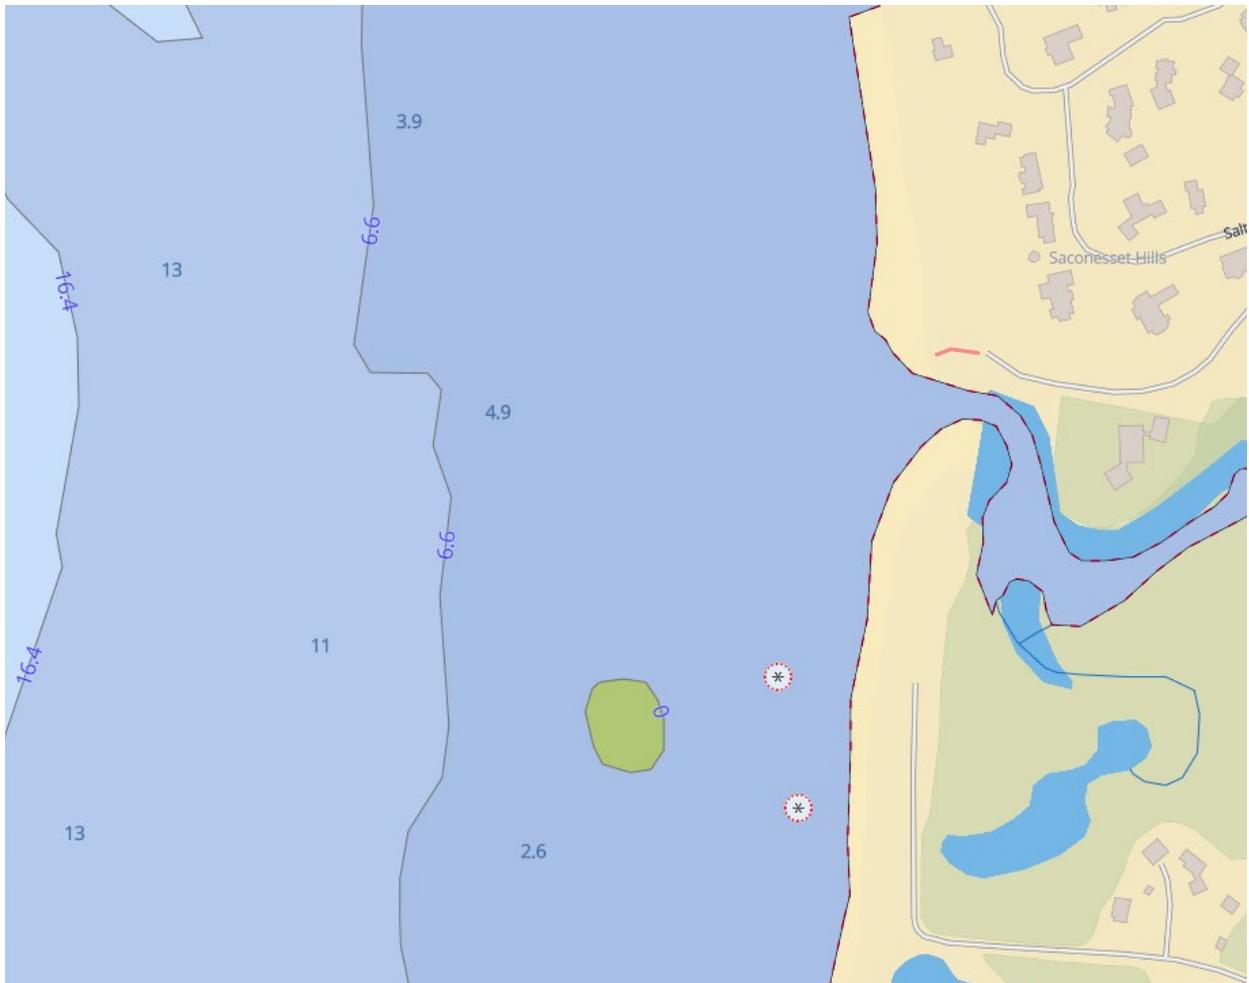
665 Figure 45 presents a navigation chart excerpt to show the nearshore area of Wood Neck  
 666 Beach (depths in feet MLW). Depths transition gradually to ~16 feet over approximately  
 667 2,000 feet.

669 *Figure 45: Wood Neck Beach Navigation Chart Excerpt of the Nearshore.*

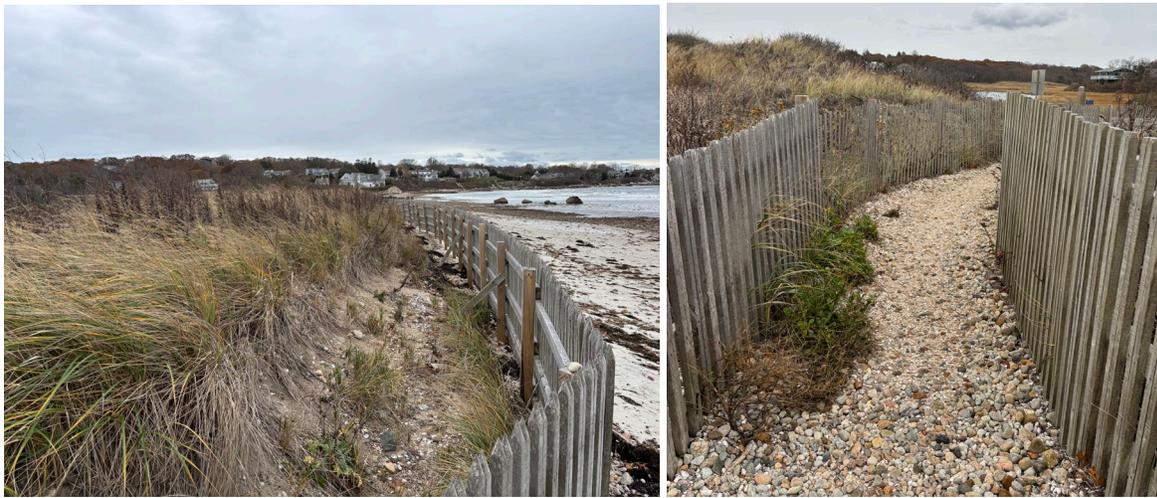
683  
684 *Figure 48: Sand fencing at Wood Neck Beach.*

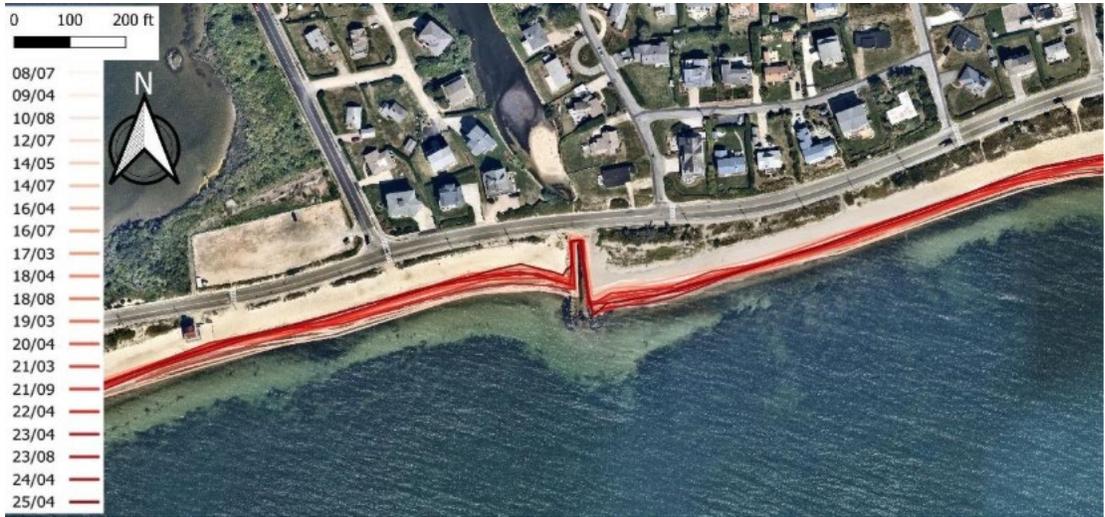
720 Surf Drive Beach is also mostly stable based on QSCAT shoreline analysis (for both east  
 721 and west beaches). Figure 51 presents the shorelines used for the analysis for the

725  
 726 *Figure 51: Shoreline change from 2008 to 2025 – Surf Drive Beach West.*

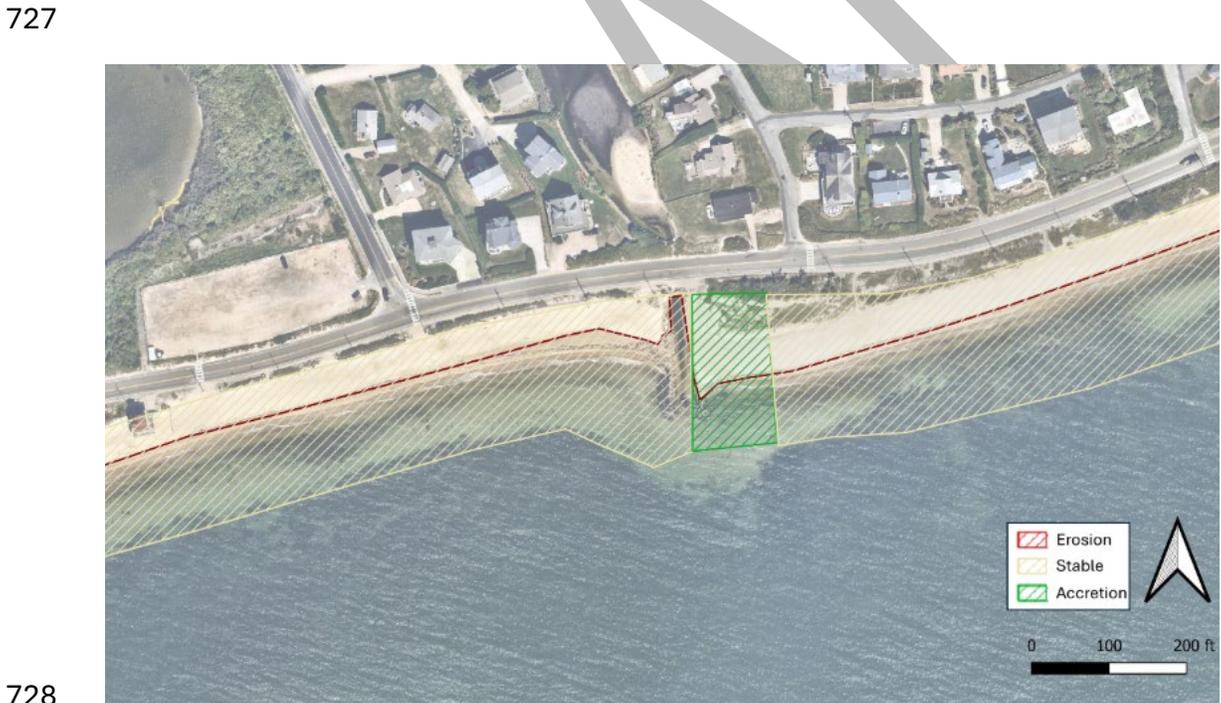
722 west beach and Figure 52 presents the blocked average results. The eastern bank of the  
 723 inlet (Fish Run) is accretional at 2.5 ft/yr. The net sediment transport direction is from east  
 724 to west although seasonal shifts in net transport direction do occur.

728  
 729 *Figure 52: Erosion/accretion pattern at Surf Drive Beach West.*

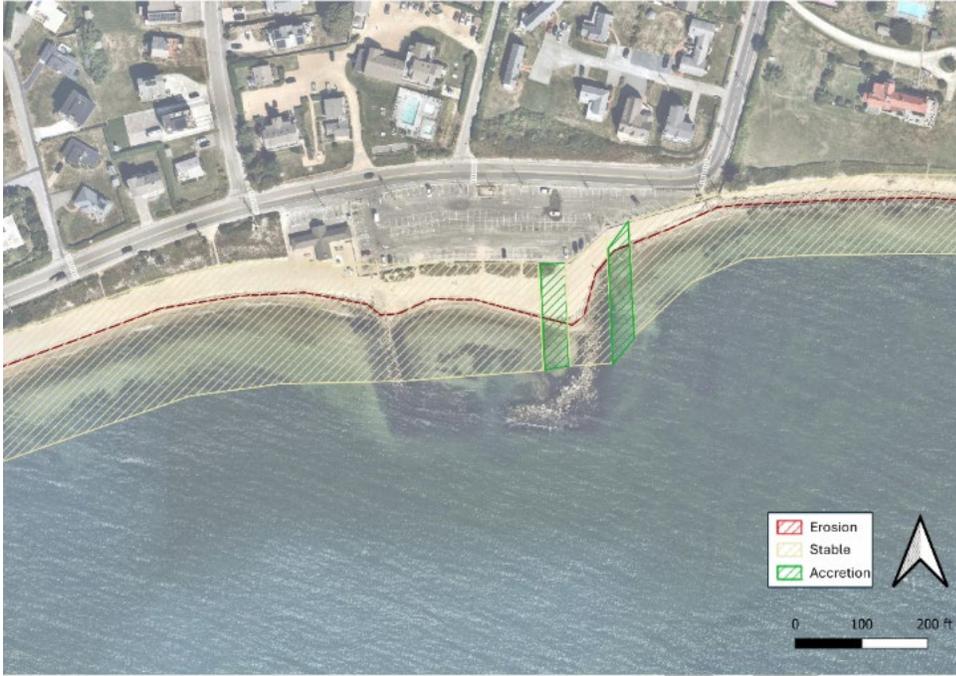
Figure 54: Erosion/accretion pattern at Surf Drive Beach East.

730 Surf Beach East spans approximately 1,000 feet of shoreline and includes a swimming  
 731 area protected by a groin and groin/breakwater. Figure 53 presents the shorelines used  
 732 for the Surf Beach East shoreline change analysis. Figure 54 presents the block

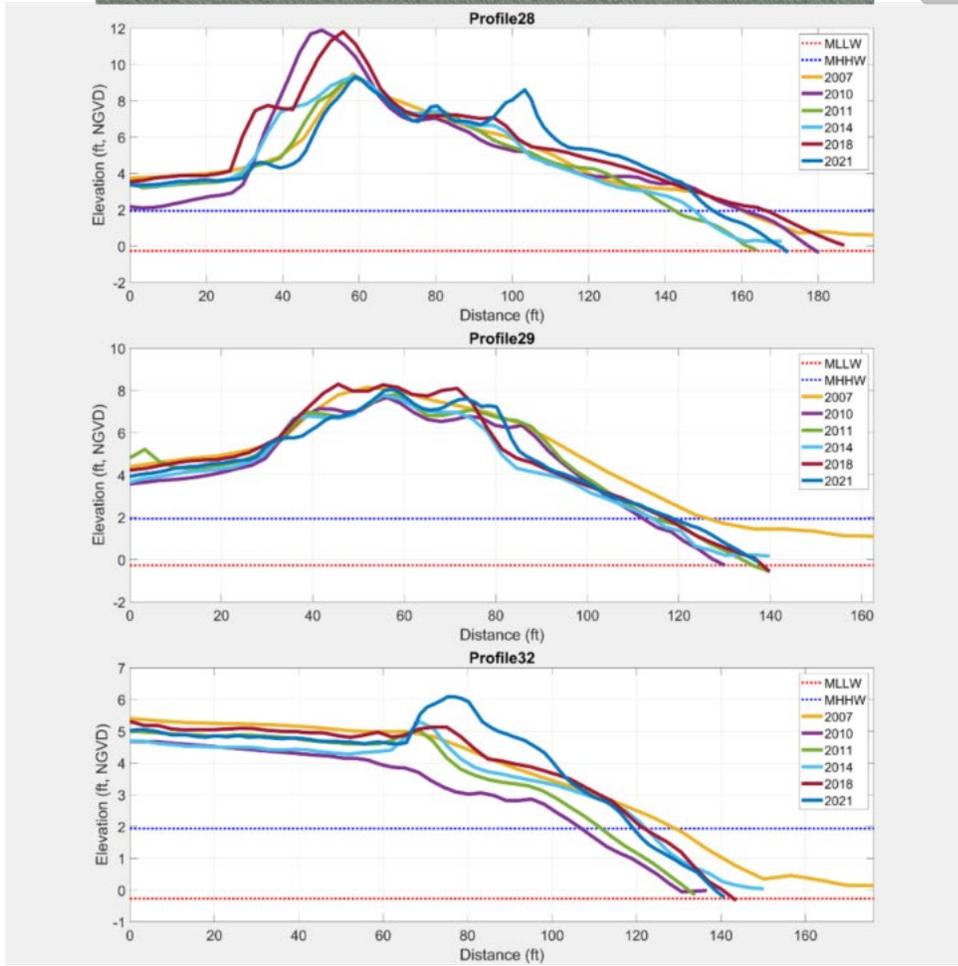
744 Figure 55: Profiles from DEMs, Surf Drive Beach.
