**2026 BEACH  
MANAGEMENT PLAN**

6 Introduction..... 1

14     Megansett Beach..... 7

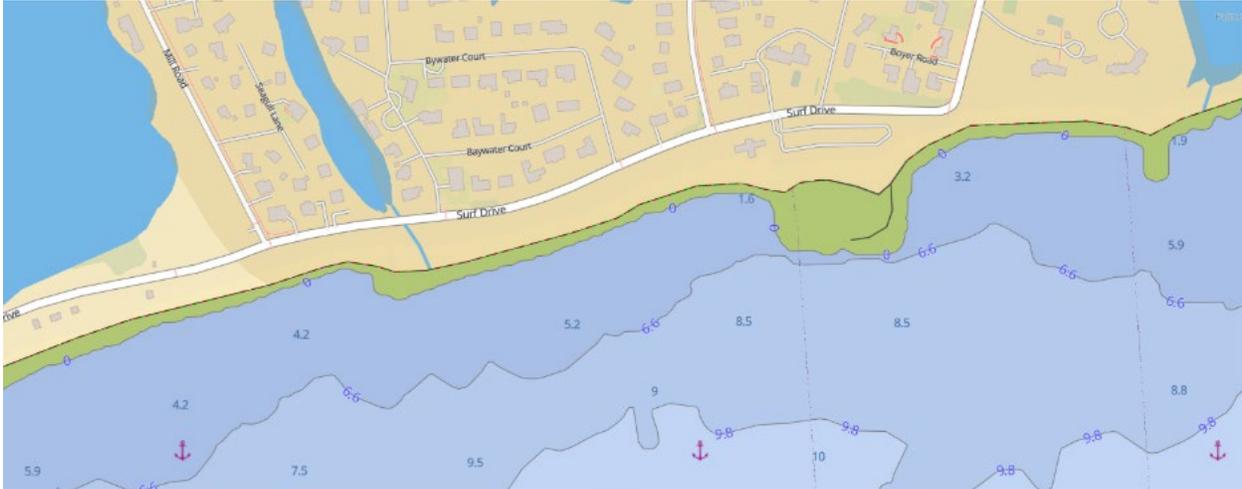
745 Figure 56 presents a navigation chart excerpt for the Surf Drive Beach nearshore. The  
 746 nearshore transitions to ~10 feet of water over ~1,000 feet.

747  
 748 Figure 56: Surf Drive Beach navigation chart excerpt showing nearshore conditions.

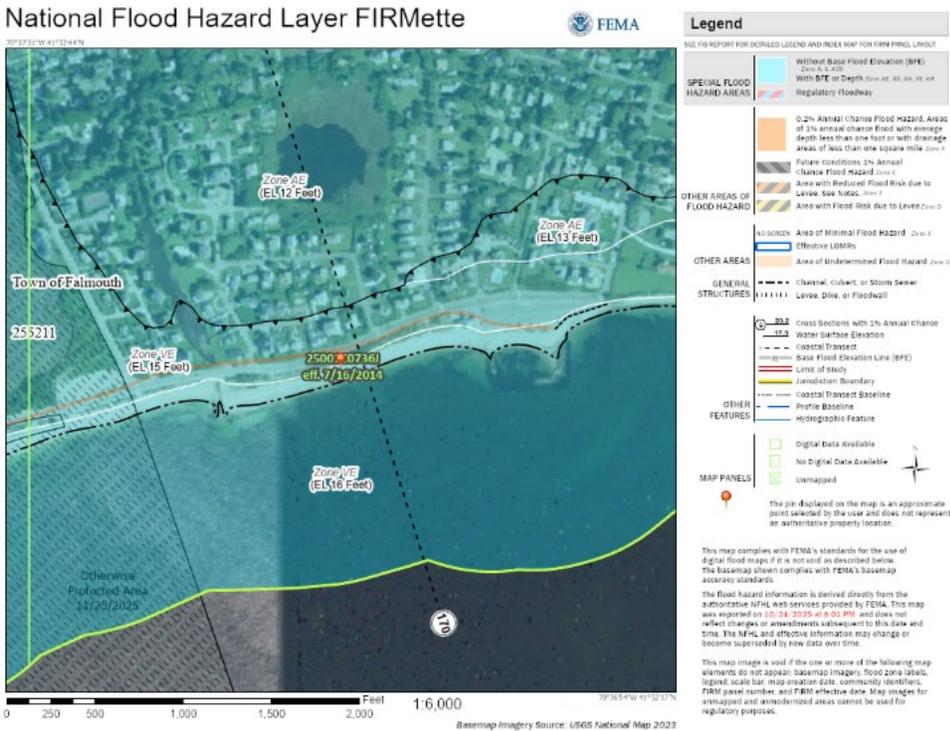
749 Figure 57 shows the current effective FIRM at Surf Drive Beach (Zone VE, 16 ft BFE).  
 750 Historical FIRMette of the area (1986) is shown in Figure 58 (Zone V18, 14 ft BFE).

751  
 752 Figure 57: FEMA FIRMette of Surf Drive Beach. Effective 07.16.2014.

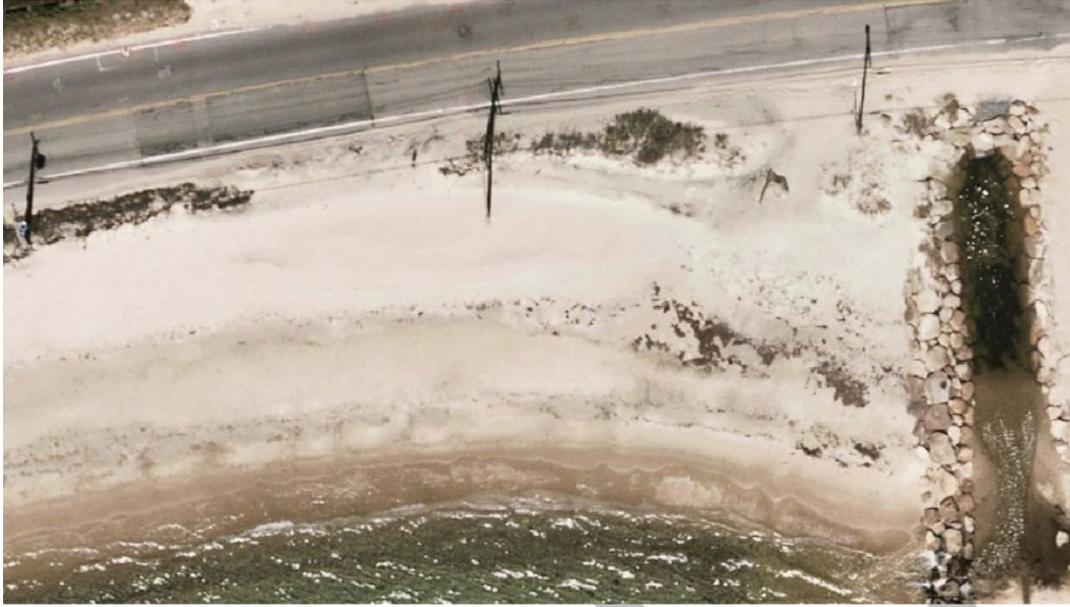
776 *Figure 60: Surf Drive Beach aerial from 2025, sand fence removed. Insert – Aerial from 2025, with sand fence.*

767 To the west of the fish run a section of sand fence was present until 2021, removed,  
768 reinstalled by 2022, removed in 2024, and reinstalled by 2025 (based on aerial inspection).  
769 The sand fence appears to impact vegetation growth on the dune, as can be seen in Figure  
770 60. The background image shows aerial image from 2024, when the sand fence was  
771 removed. The section of dune has no vegetation visible. The inserted image on the bottom  
772 right is from 2025, where the sand fence is installed. Patches of vegetation are starting to  
773 fill out once again.

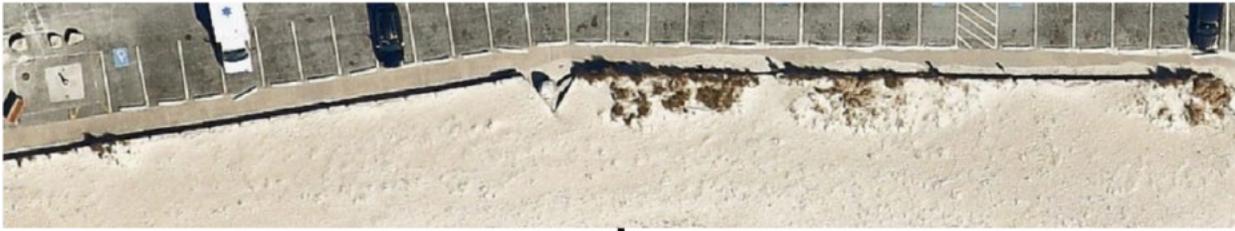
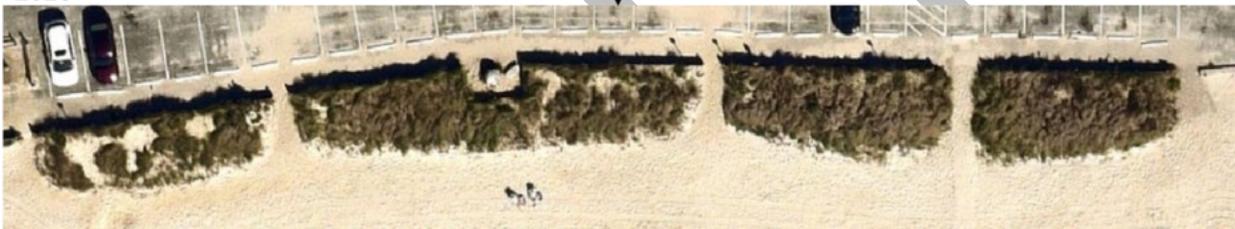
786 *Figure 61: Surf Drive Beach Parking Lot Alteration, 2020 to 2025.*

777 The parking lot fence has undergone modifications in 2021, which is shown in Figure 61.

783 Surf Drive Beach was graded and nourished in 2020 and nourished again in 2023. Sediment  
784 quantities are unknown.

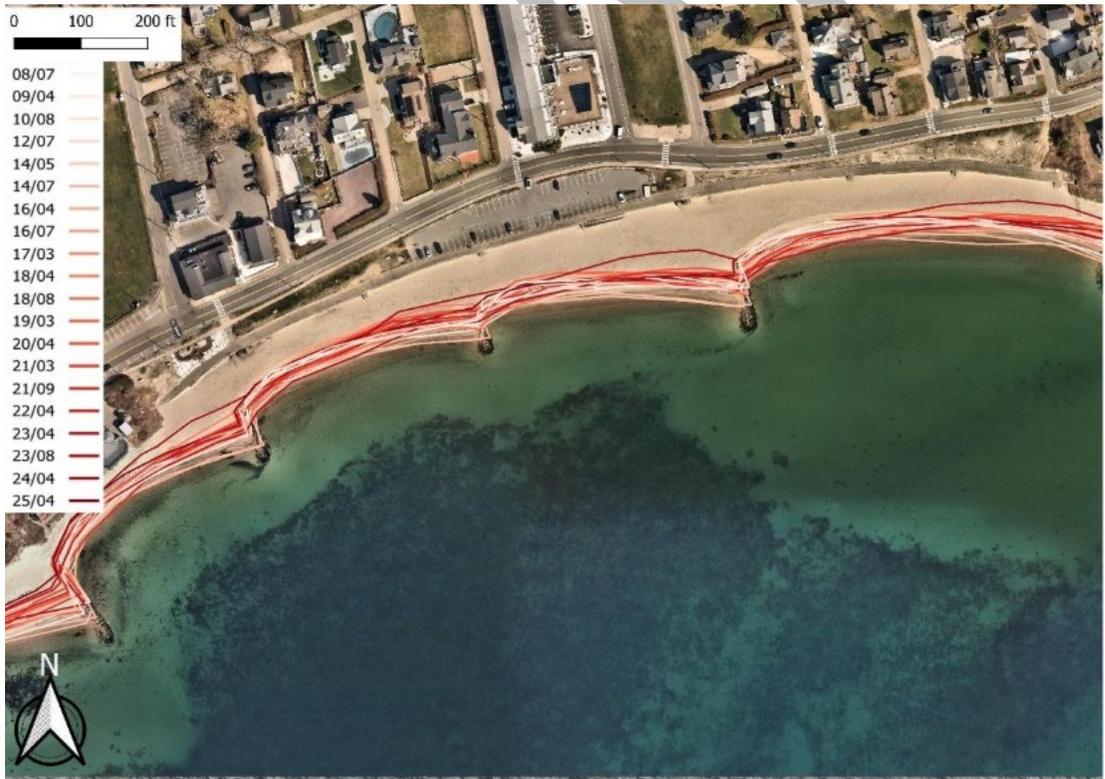
828 *Figure 63: Shoreline change from 2008 to 2025 – Falmouth Heights Beach.*

821 Falmouth Heights Beach is a south-facing beach overlooking Vineyard Sound and spans  
822 approximately 2,000 feet. Falmouth Heights Beach is composed of a Coastal Beach and  
823 Land Subject to Coastal Storm Flowage (LSCSF) that ends in a continuous sea wall at its  
824 landward extent. The seawall extends for 0.2 miles between Central Park Court and  
825 Darmouth Ave with no statistically significant erosion or accretion. Figure 63 presents  
826 shorelines used for the analysis and Figure 64 presents block average QSCAT results.

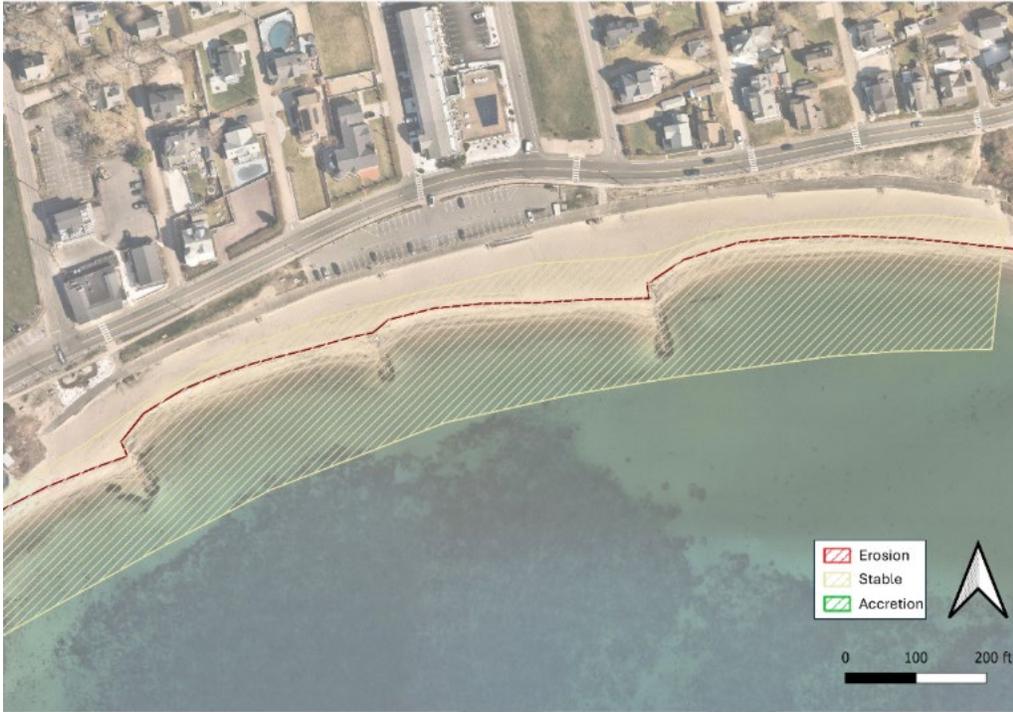
830 *Figure 64: Erosion/accretion patterns at Falmouth Heights Beach.*

831 Sediment has accumulated on the western side of the groins, suggesting easterly  
832 sediment transport patterns. The dune elevations are also stable over the years (Figure  
833 65) based on available DEM data.

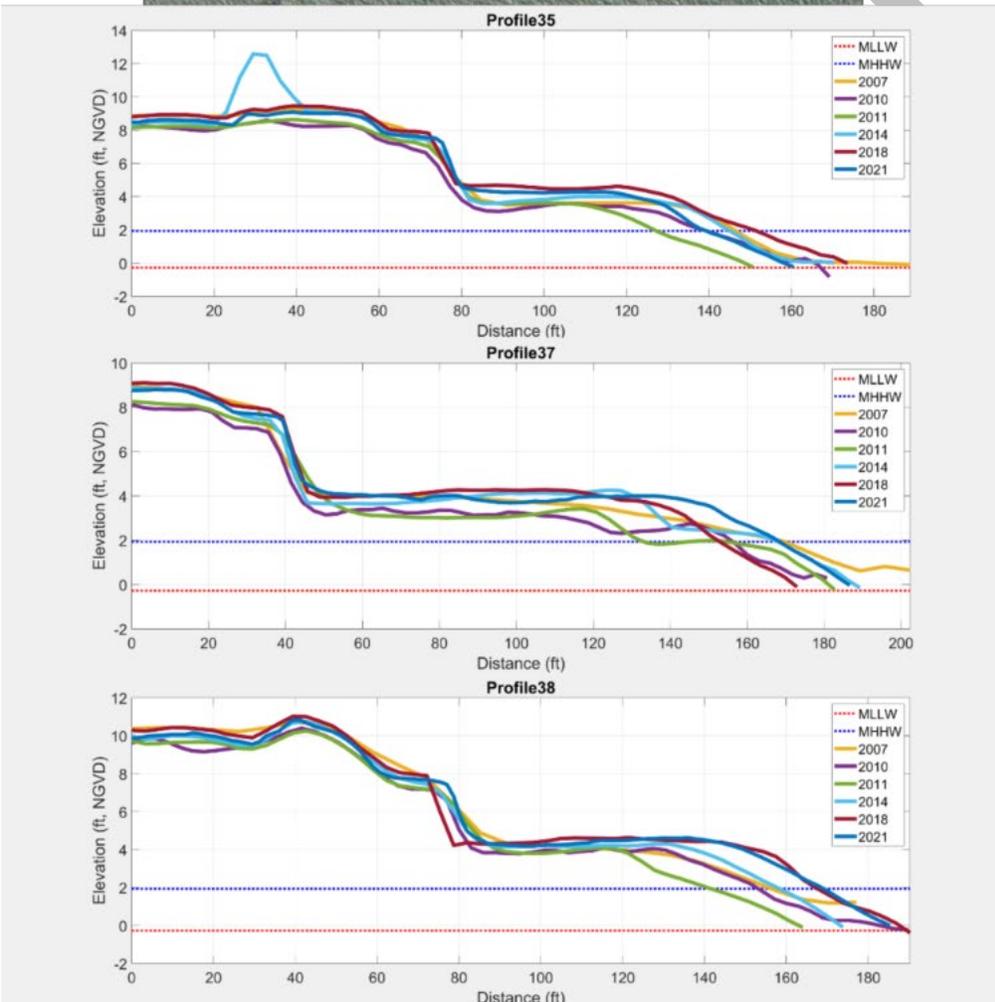
835 *Figure 65: Profile from DEMs, Falmouth Heights Beach.*

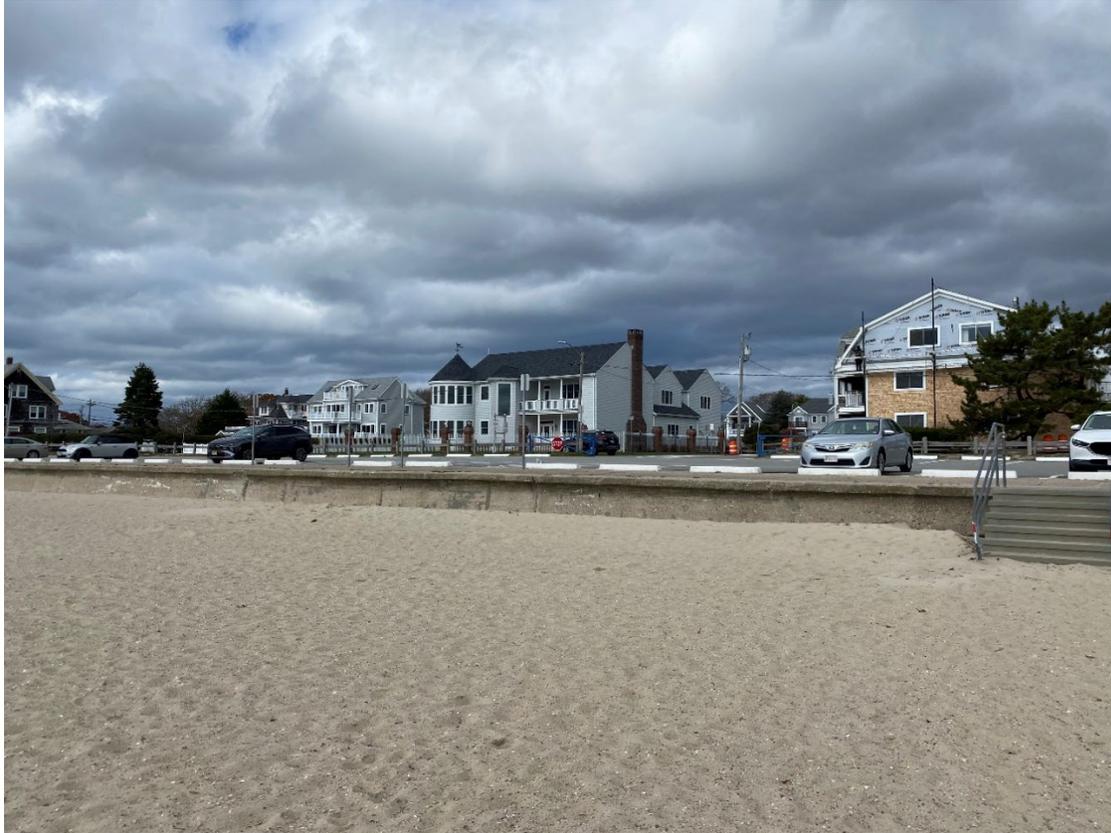
852 Falmouth Heights Beach is seasonally re-graded to redistribute winter sand buildup along  
 853 the seawall. Existing structures along Falmouth Heights Beach include several groins.

855 *Figure 69: Falmouth Heights seawall and paved parking area.*

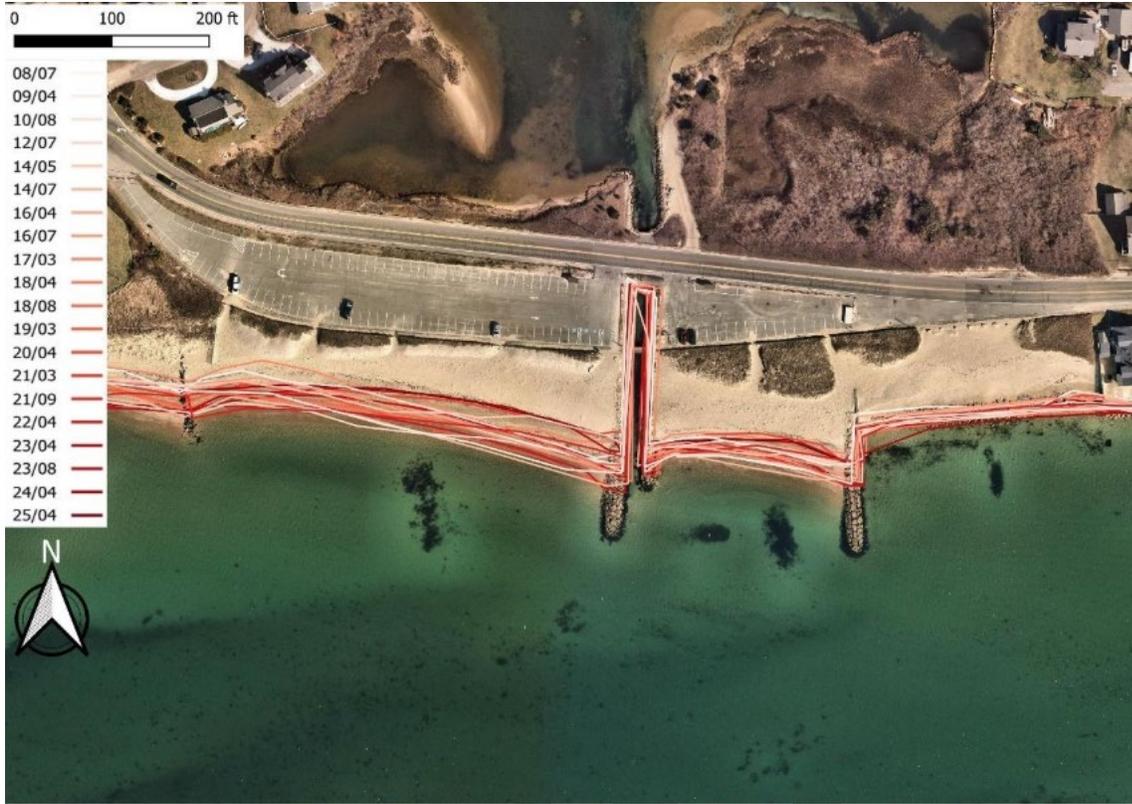
897 *Figure 73 :Shoreline change from 2008 to 2025 – Bristol Beach.*

891 Figure 73 presents shorelines used in the analysis and Figure 74 presents block  
892 average QSCAT results. Bristol beach is stable overall, except to the west of the inlet which  
893 is retreating at a rate of -1.5 ft/yr. This appears to be due to slowing eastward  
894 longshore sediment transport, as beach section immediately updrift (east) to the section  
895 of erosion shows statistically insignificant accretion (<1ft/yr).

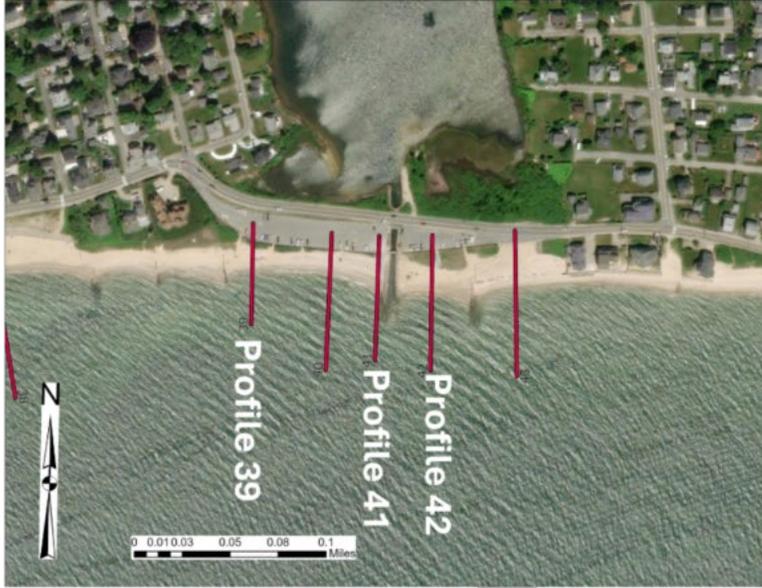
904 *Figure 75: Profile from DEMs, Bristol Beach.*

901 Figure 75 presents extracted DEM profiles for Bristol Beach. Dunes have grown in height  
902 since 2010. It appears that Bristol beach is stable to slightly accretional overall.

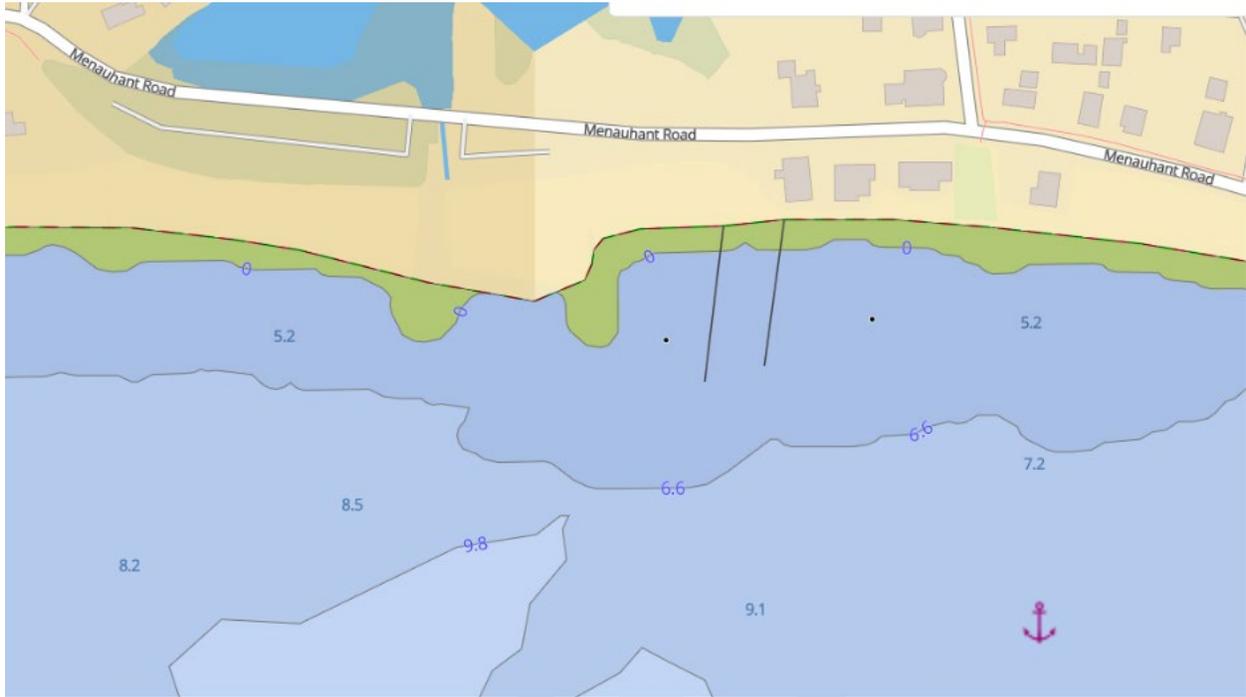
907  
 908 *Figure 76: Navigation chart excerpt showing Bristol Beach nearshore.*

905 Figure 76 presents a navigation chart excerpt showing the Bristol Beach nearshore. The  
 906 nearshore transitions to ~10 feet of water over ~1,000 feet.

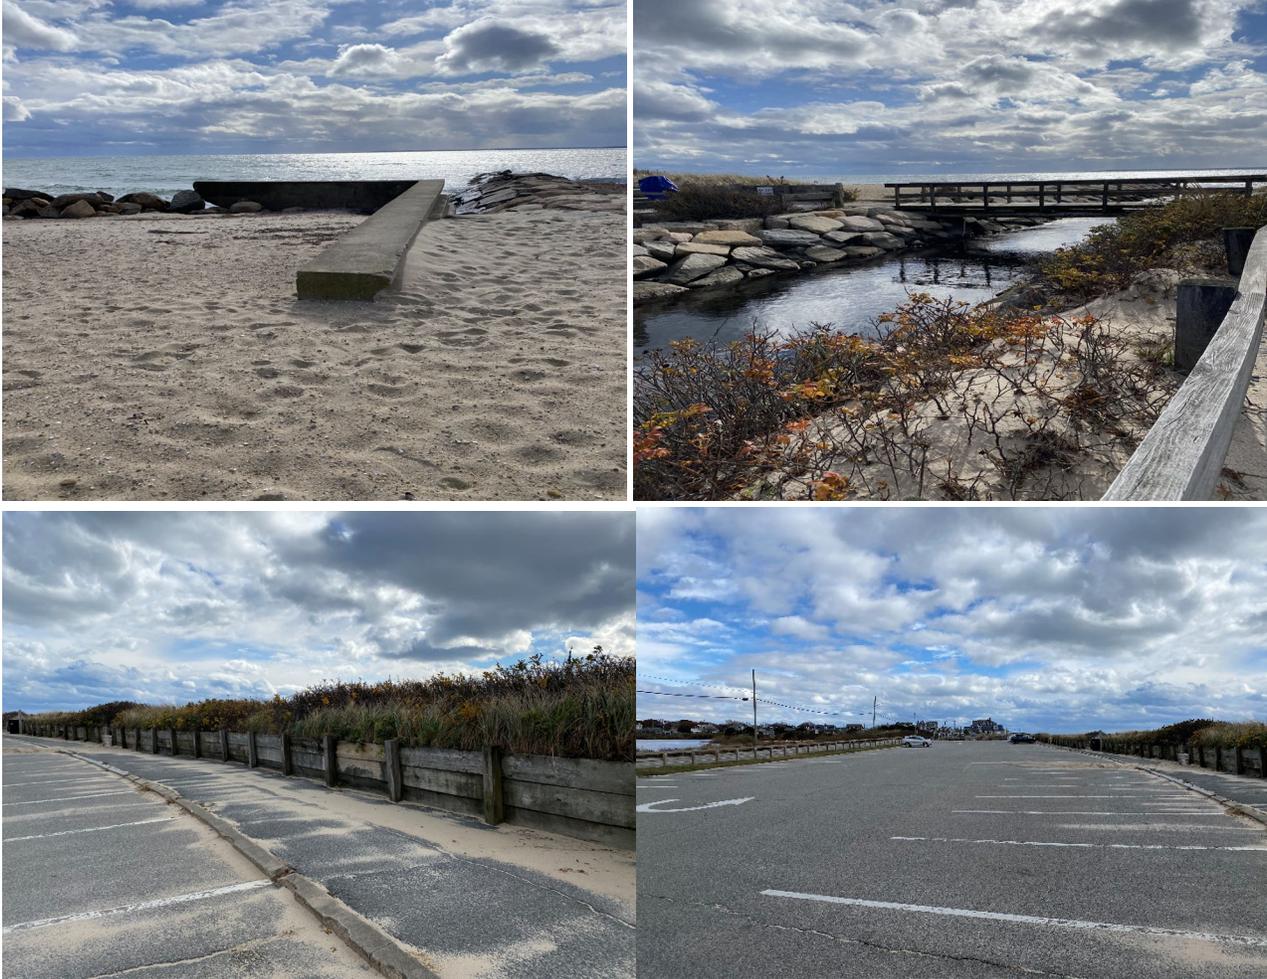
928 *Figure 79: Seawall at Bristol Beach – East (top left) and tidal inlet to Little Pond estuary (top right). At Bristol Beach – West,*  
929 *a wooden retaining wall along the dunes (bottom left) and paved parking lot.*

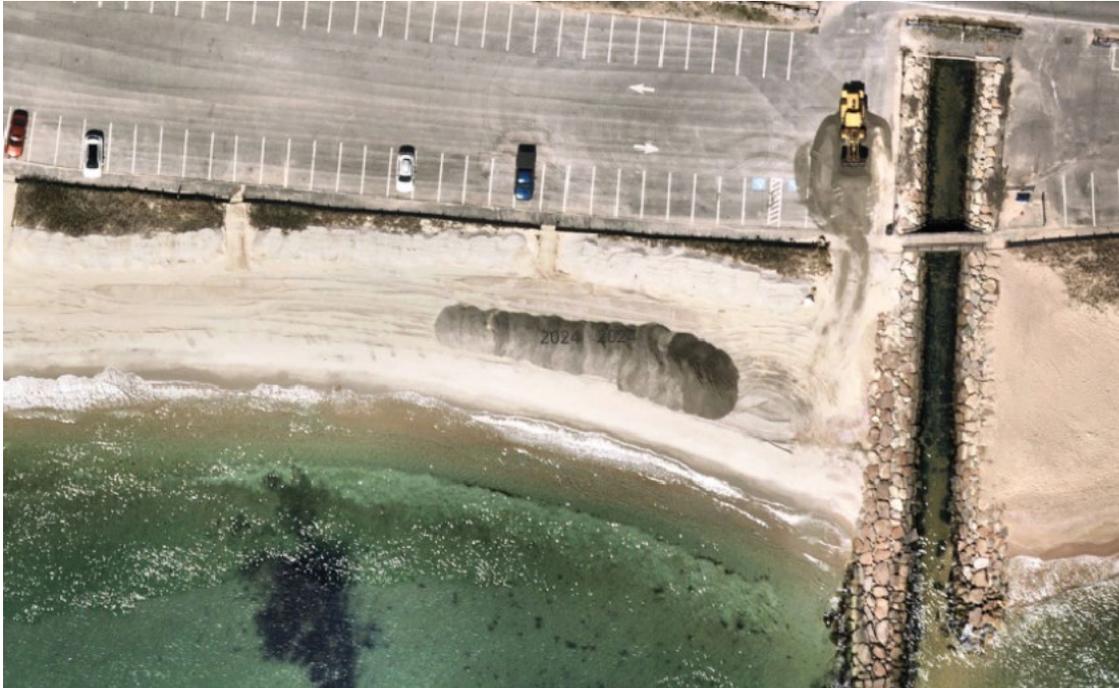
935 *Figure 80: Bristol Beach renourishment, 2024.*

930 The section of shoreline immediately west of the inlet was renourished in 2024, as can be  
931 seen in Figure 80. At the eastern end of the parking lot, a rectangular structure fronting the  
932 dunes was removed in 2020 (Figure 81). Since then, the dune vegetation has slowly grown  
933 into the spot that was previously occupied by the structure

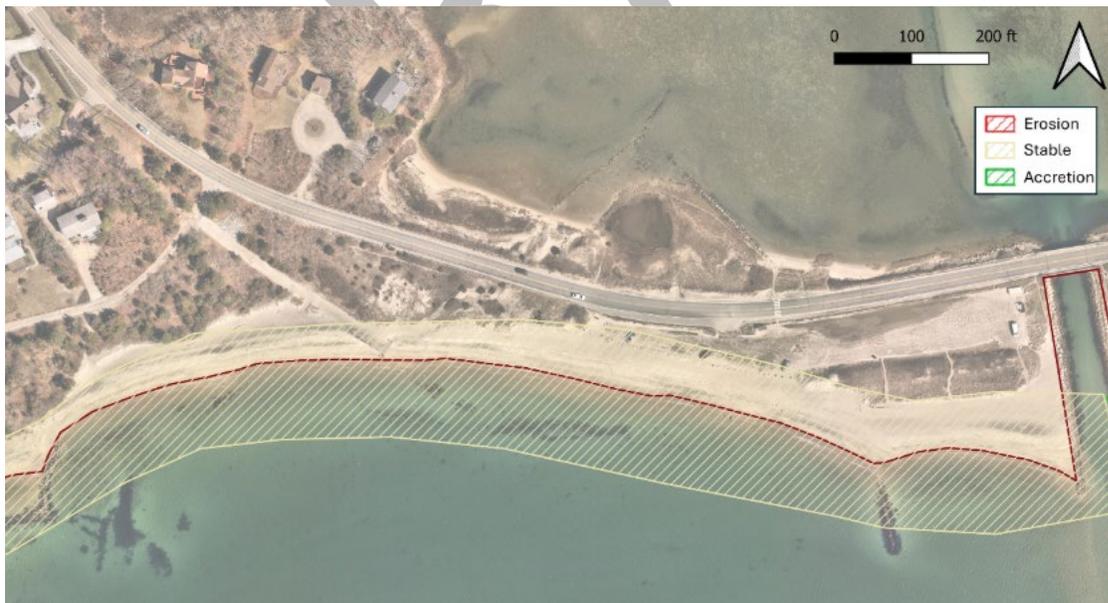
975 *Figure 84: Erosion/accretion pattern at Menauhant Beach West.*

965 This inlet is dredged to maintain navigable depths, with the dredged material being  
966 deposited onto the East and West beaches. The effects of this can be seen in the  
967 accretional signal (5 ft/yr) on the beach immediately to the east of the inlet. Some  
968 nourishment material has also been placed on the West beach (downdrift of the  
969 inlet). Figure 83 presents the shorelines used for the QSCAT analysis on the West  
970 beach. Figure 84 presents blocked average QSCAT West beach results. The West beach is  
971 characterized as stable which appears at least partially due to nourishment activity.

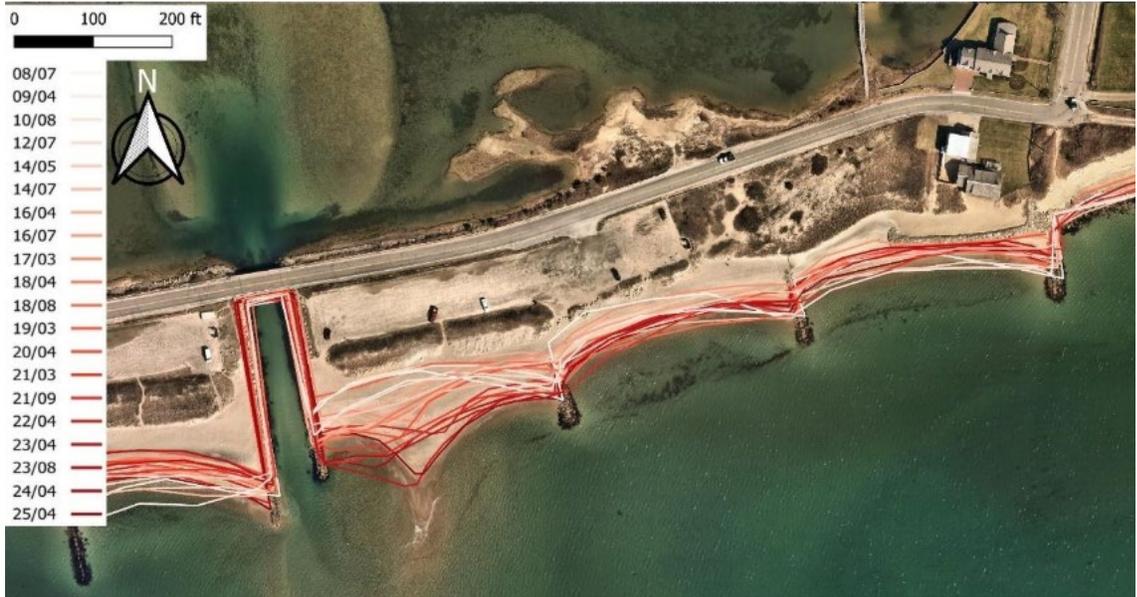
982 *Figure 85: Shoreline change from 2008 to 2025 – Menauhant Beach East*

976 Figure 85 presents the shorelines used for the QSCAT analysis while Figure 86 presents  
977 block average result for the East beach. The shore to the east shows signs of accretion at  
978 2.5 ft/yr, which also appears to be the result of the dredge spoil deposit. Further eastward  
979 sections of the beach are stable and do not show statistically significant erosion or  
980 accretion.

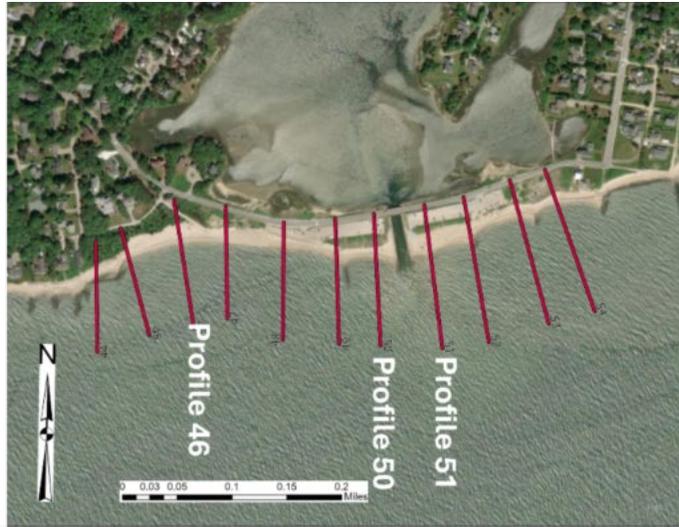
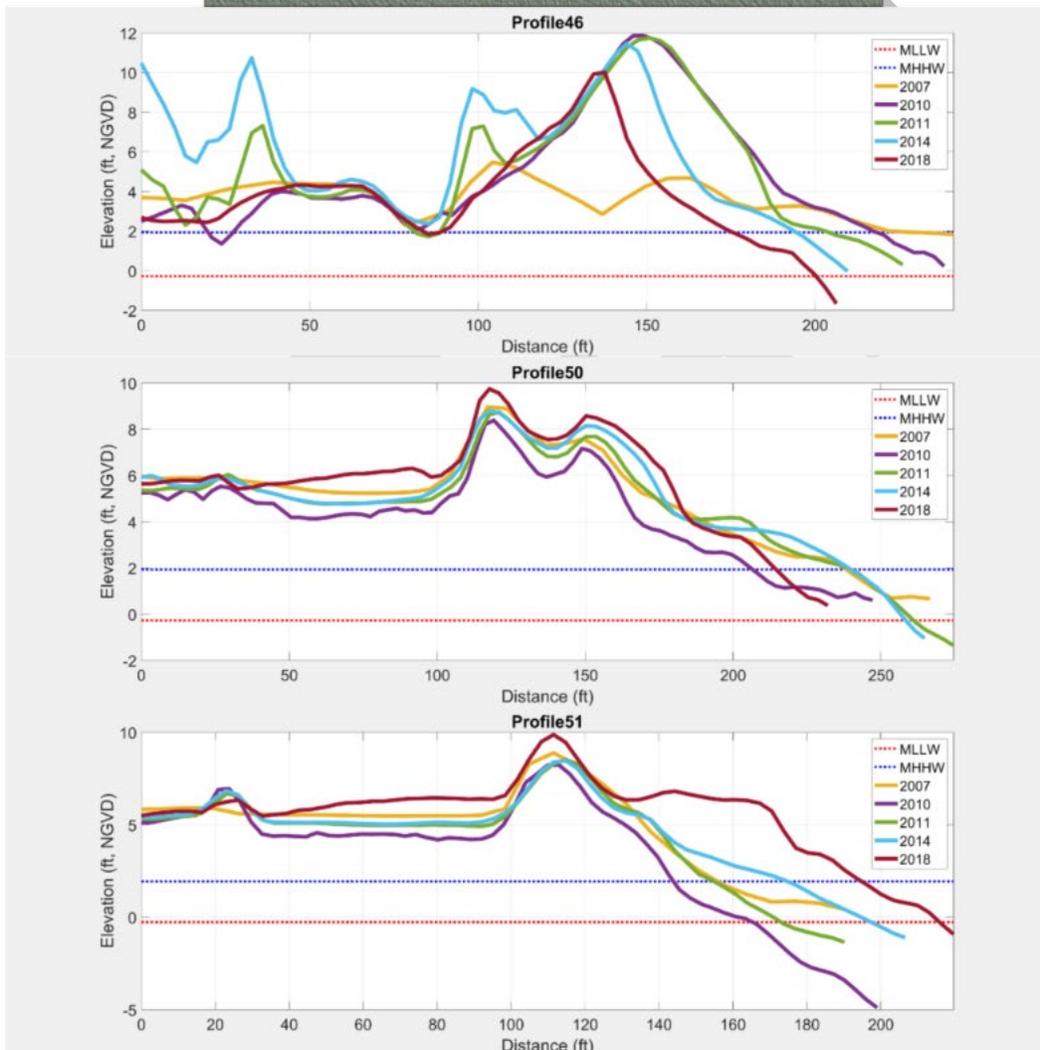
986 Figure 87 presents extracted DEM profiles along Menauhant Beach East and West.  
987 Significant accretion is noted at Profile 51 for the 2018 profile, noting that nourishment  
988 activity related to inlet maintenance activity occurs sporadically along this  
989 shoreline. Figure 88 presents an aerial during dredging of Bournes Pond Inlet.  
990

992 *Figure 87: Profiles from DEMs, Menauhant Beach.*

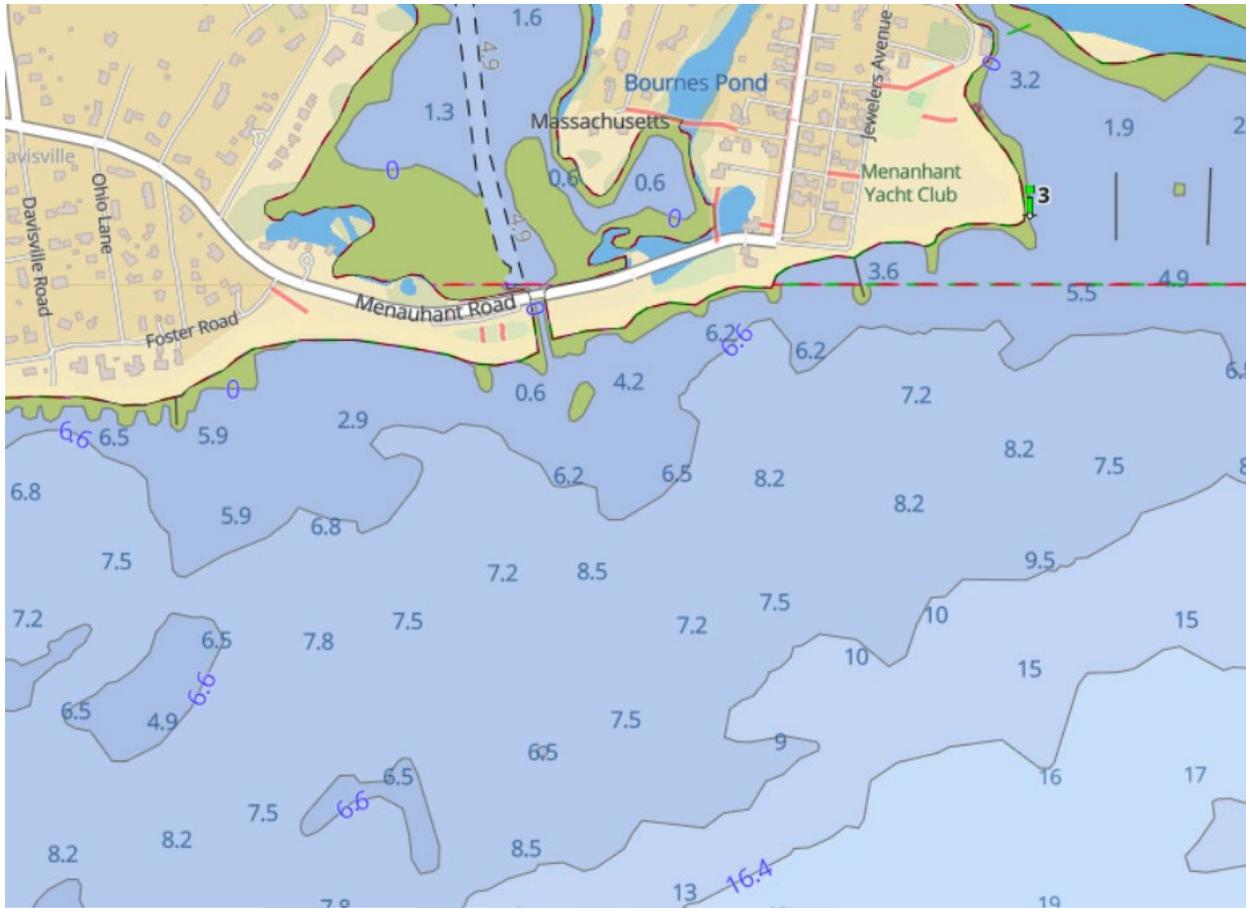
996 Figure 89 presents a navigation chart excerpt of the Menauhant Beach nearshore. Depths  
997 transition to ~10 feet deep over ~2,000 feet.

999 *Figure 89: Navigation chart excerpt of the Menauhant Beach nearshore.*

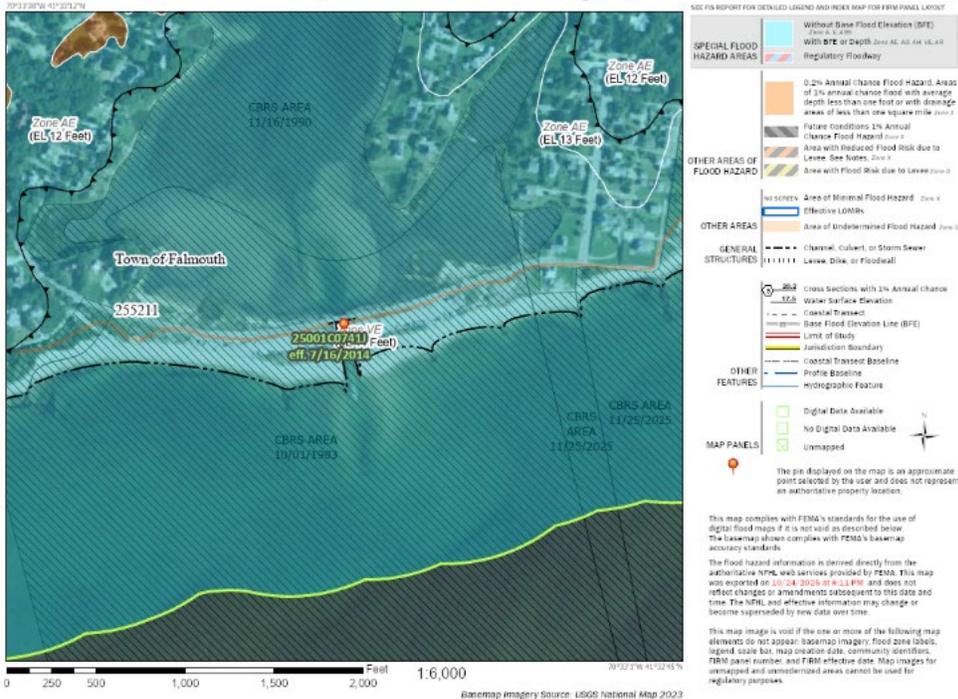
1003 Figure 90: FEMA FIRMette of Menauhant Beach. Effective 07. 16. 2014.

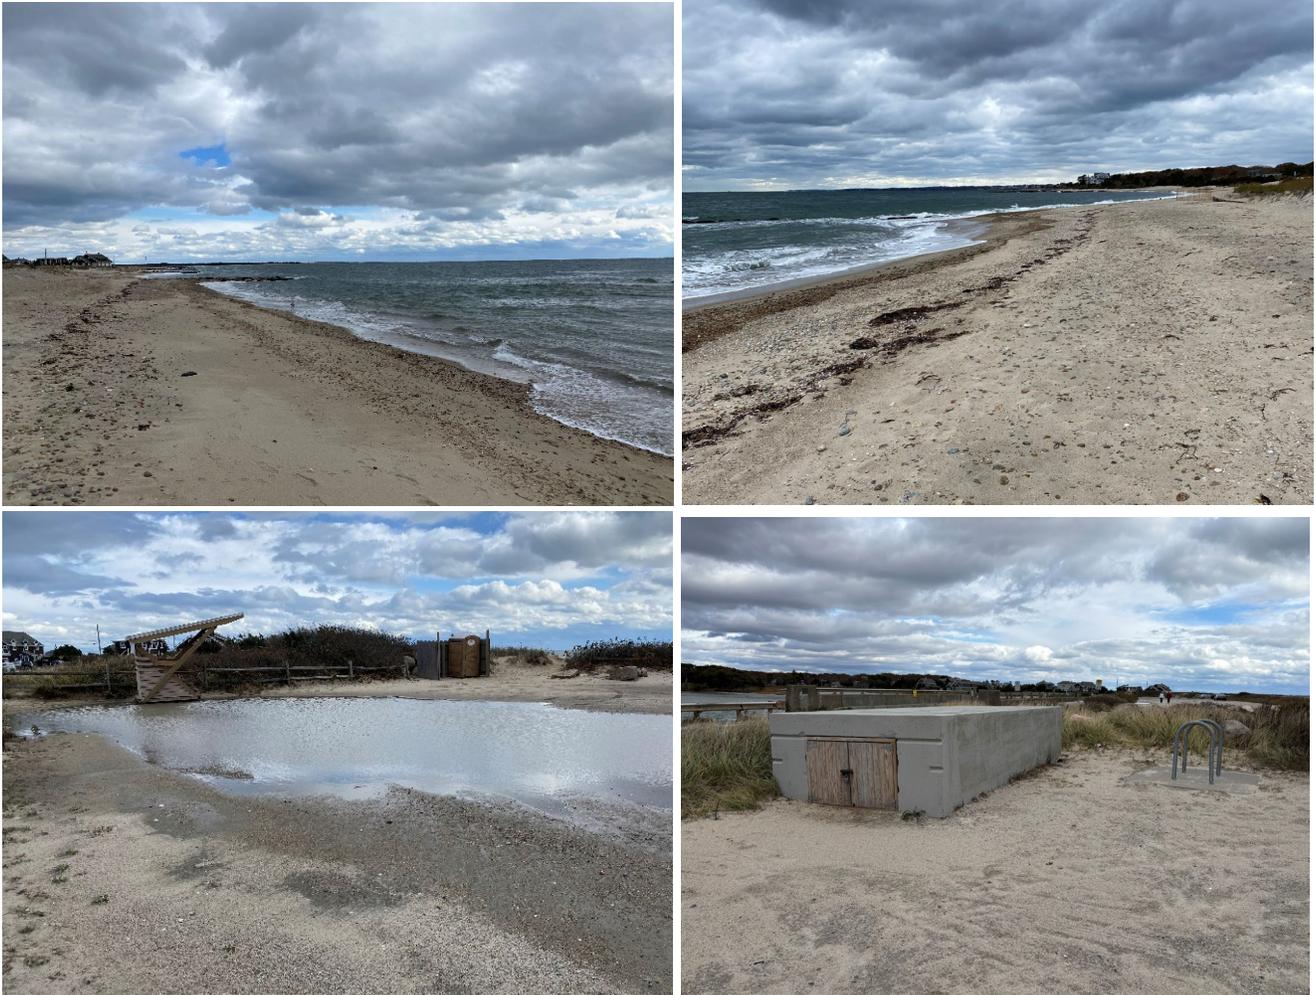
1008 There are two natural surface parking areas at Menauhant West and East. The beach  
1009 contains two stone jetties, with an additional stone groin and rip rap structures at  
1010 Menauhant West, and two stone groins at Menauhant East. Split rail fencing lines the edge  
1011 of the parking lot adjacent to Menauhant Road. A concrete storage vault is located in the  
1012 parking area of Menauhant West.

1013 *Figure 92: Menauhant Beach East (top right) and West (top right). Natural surface parking lot at East (bottom left) and*  
1014 *equipment tomb at parking lot West (bottom right).*

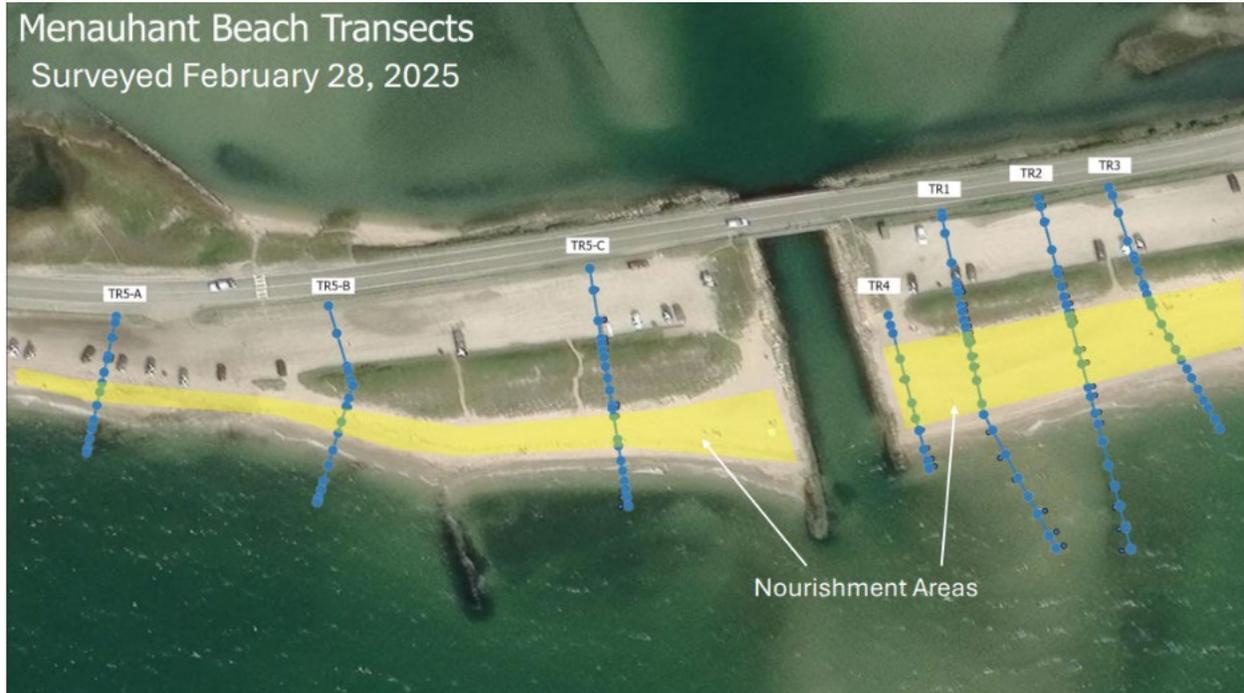
1021  
1022 *Figure 93: 2024 Menauhant Beach nourishment (Beneficial Use of Dredged Material) from Eel River Entrance Channel.*

1015 Menauhant West was nourished in 2023, 2024 (completed in January 2025). Sediment  
1016 piles from that year can be seen staged in the parking lot in Figure 94. The Town of  
1017 Falmouth sponsored the Eel River Entrance Channel dredging and beneficial use  
1018 placement on Menauhant Beach. Figure 93 presents a post-project overview of beach

1019 placement that was sent to regulatory agencies. Approximately 5,000 cubic yards  
1020 (cy) was placed.

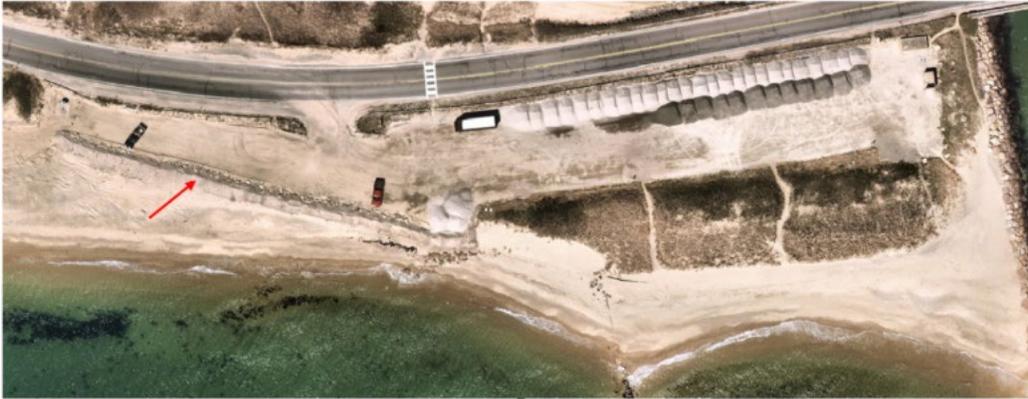
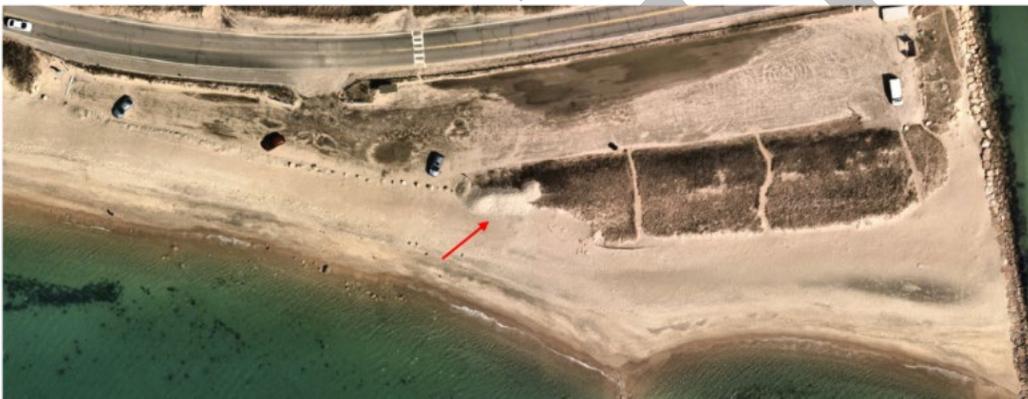
1028 *Figure 94: Menauhant Beach West, renourishment.*

1023 Also in 2024, the Town attempted to re-establish a section of vegetated dune (red  
1024 arrow) along the western edge of the parking lot (Figure 94).

1025 In 2025, dune is no longer present and boulders were placed to edge the parking area. A  
1026 sand pile is visible (red arrow) which was distributed along the beach (Figure 94).

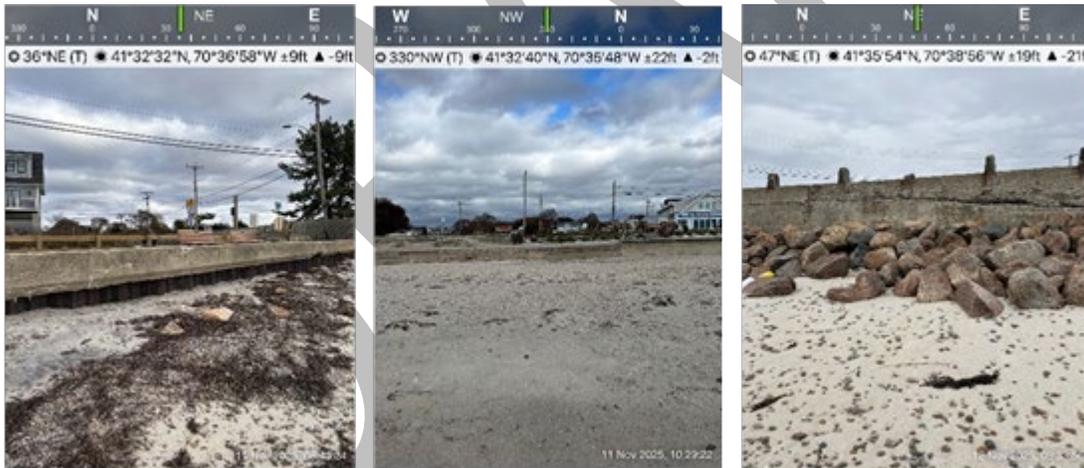
Figure 99: Seawalls at Surf Ave Beach (left), Falmouth Heights Beach (center), and Chapoquoit Beach (right)
